Agne Andersson  
Heléne Annadotter  
Johan Forssblad  
Emil Grönkvist

ÖSTRA  
GÖINGE

# A study of four constructed wetlands in the catchment of Lake Immeln Hövidstorp wetland

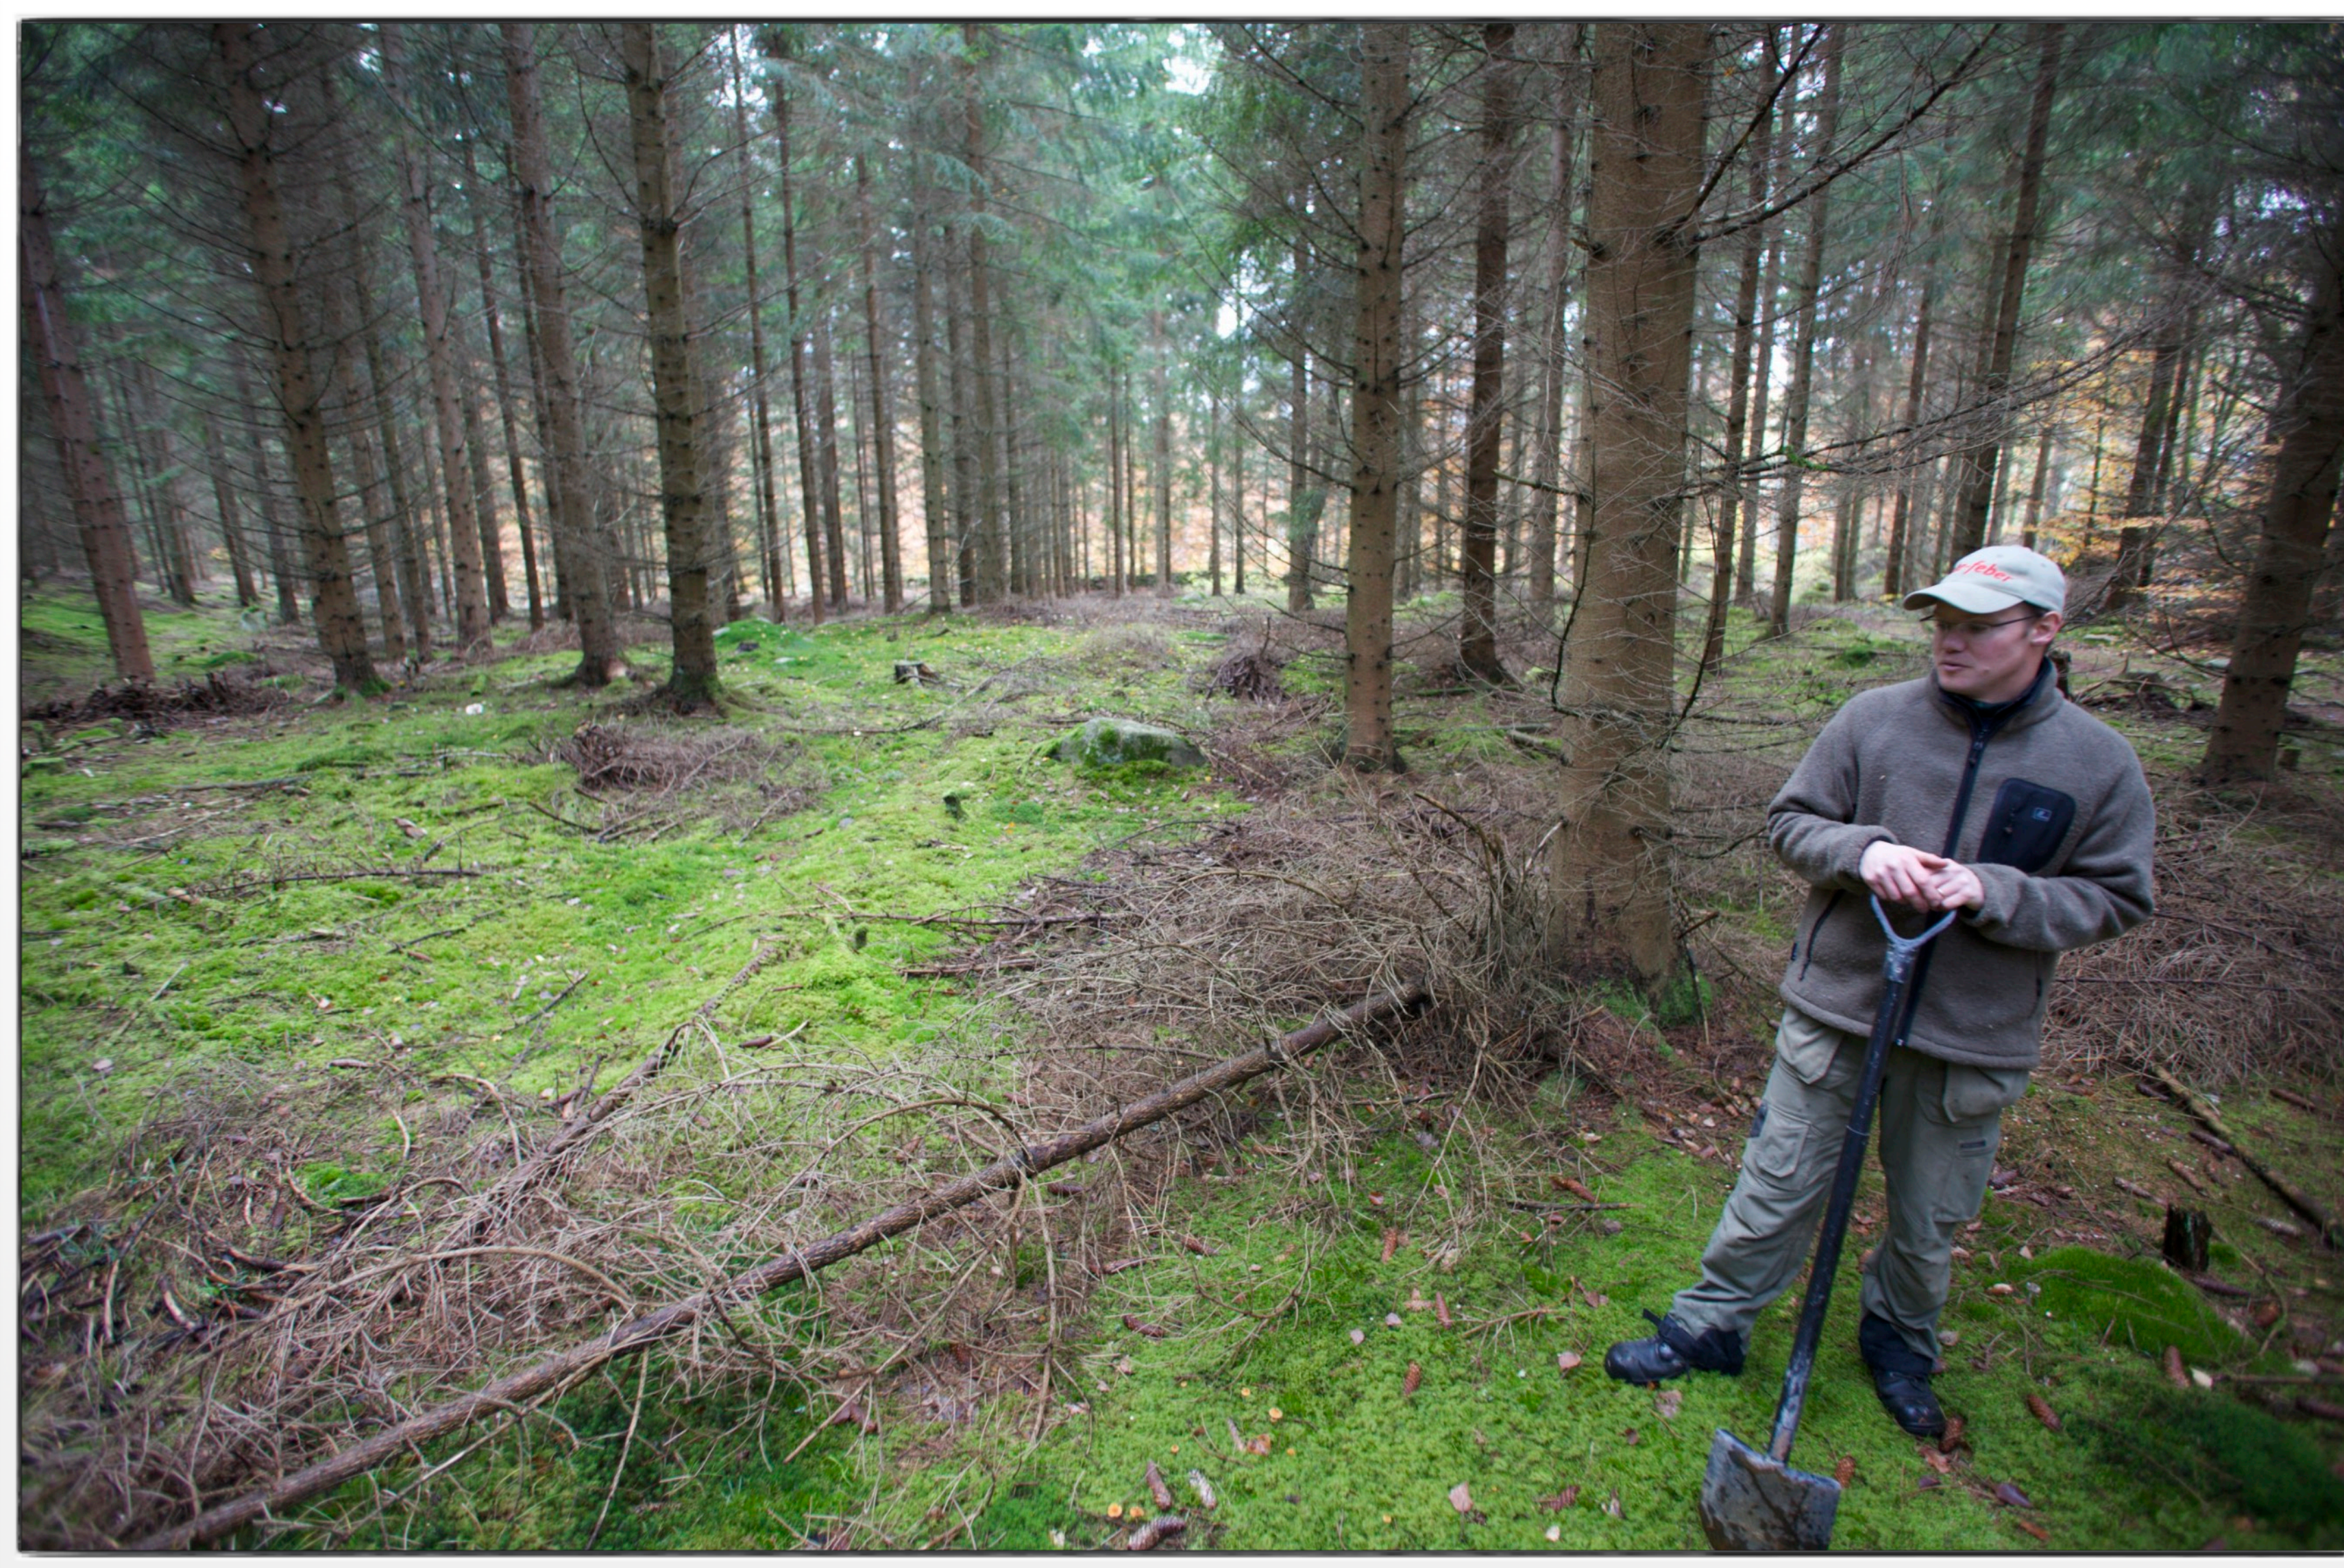
This wetland was created with gently sloping edges to prevent erosion and to be able to store a large amount of water

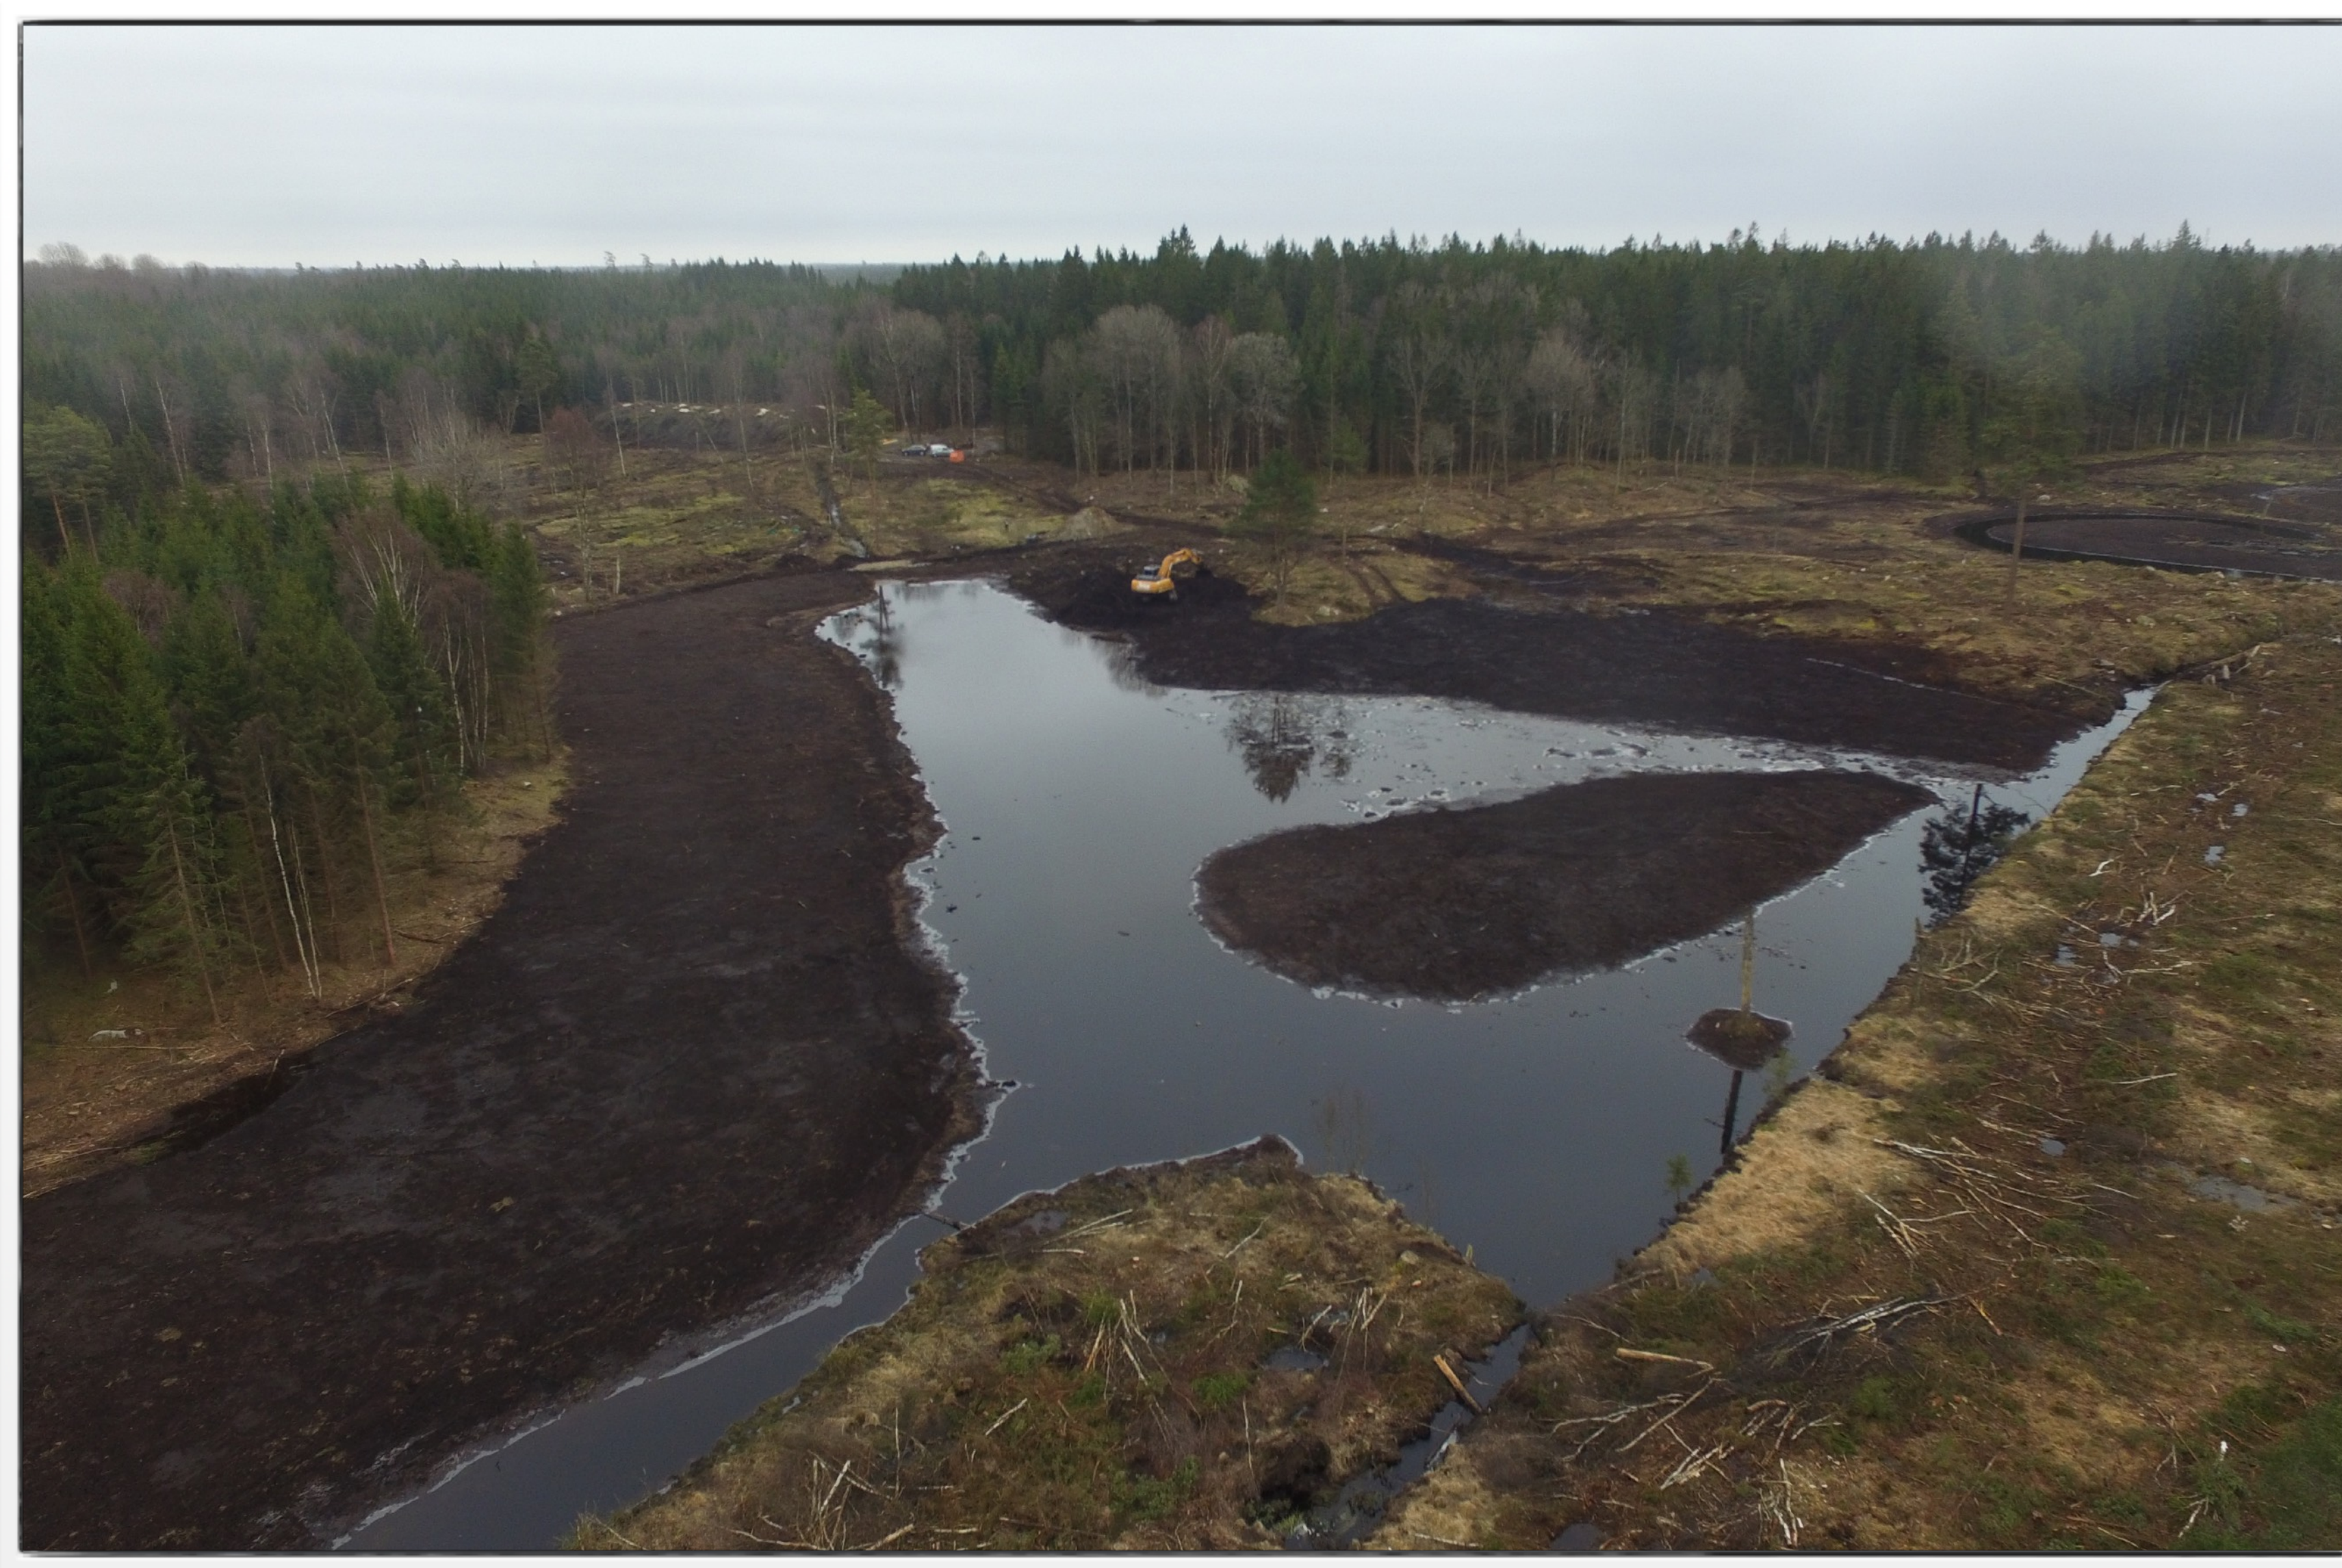
At the shores of the wetland, beach meadows were created  
and different herbs were planted  
At these meadows, a large number of animals, from insects to moose,  
find food

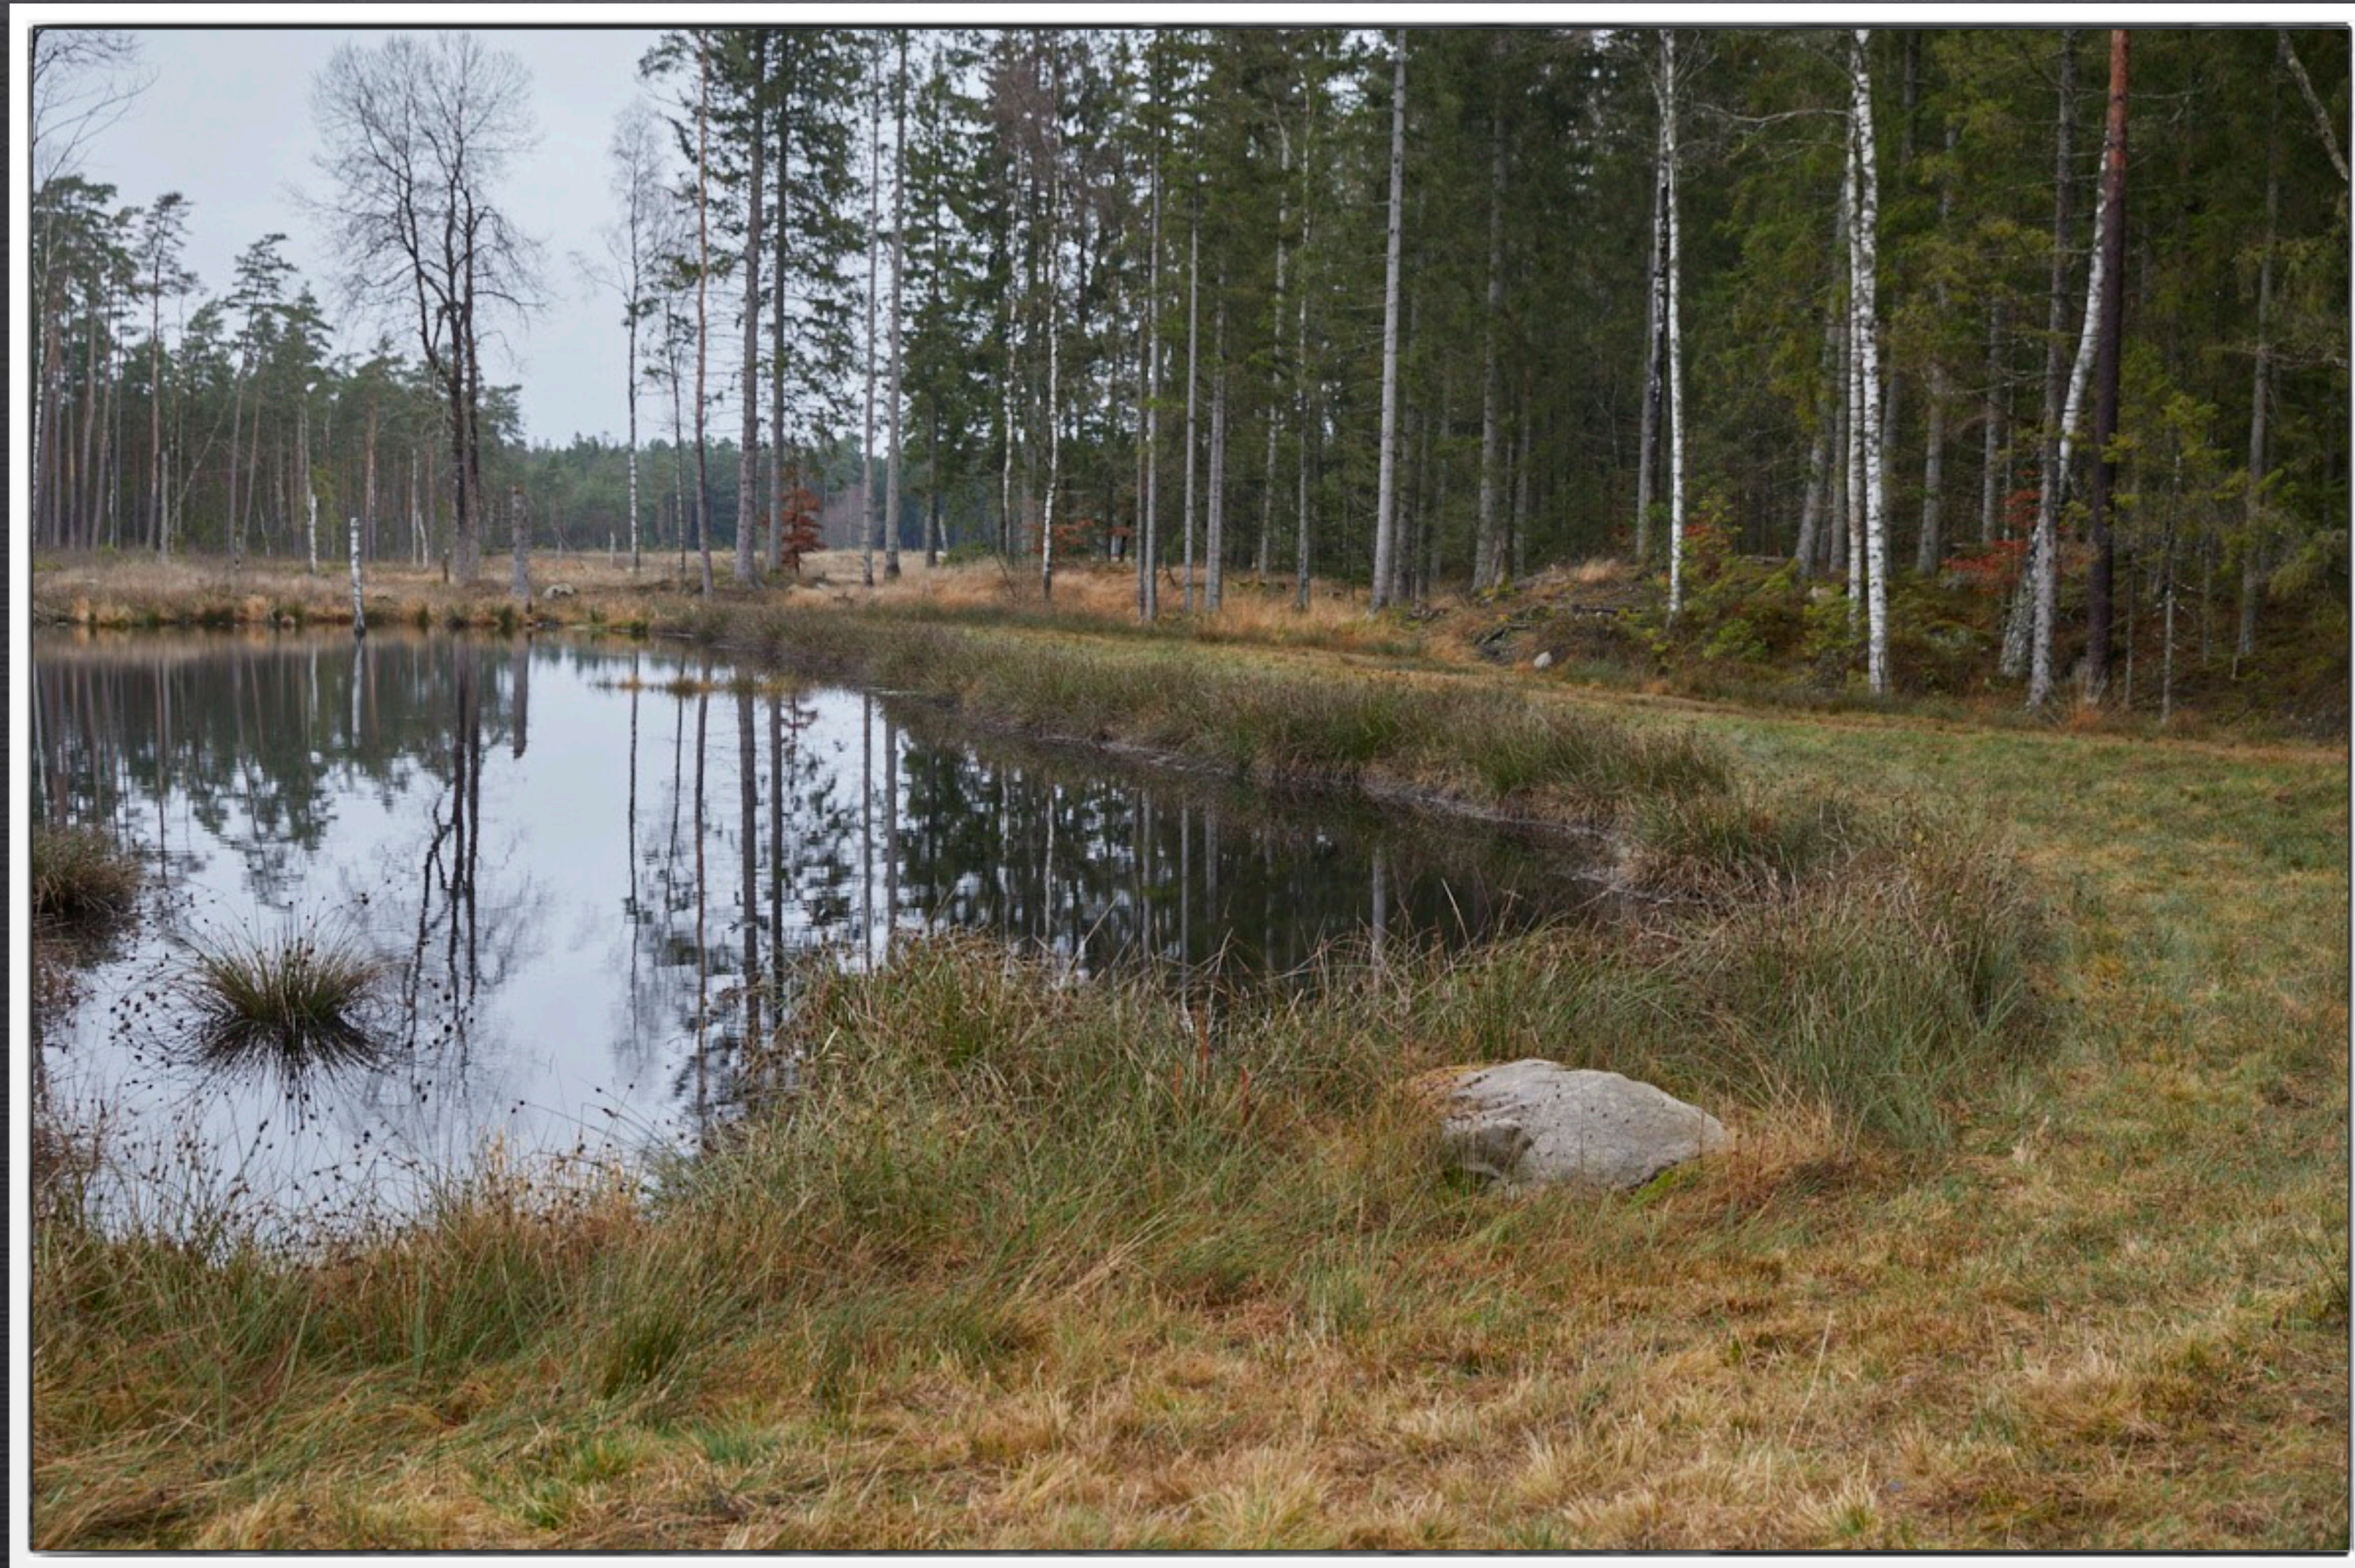
HÖVIDSTORP 2022-09-14

In 2022, a large number of physical and chemical factors have been measured

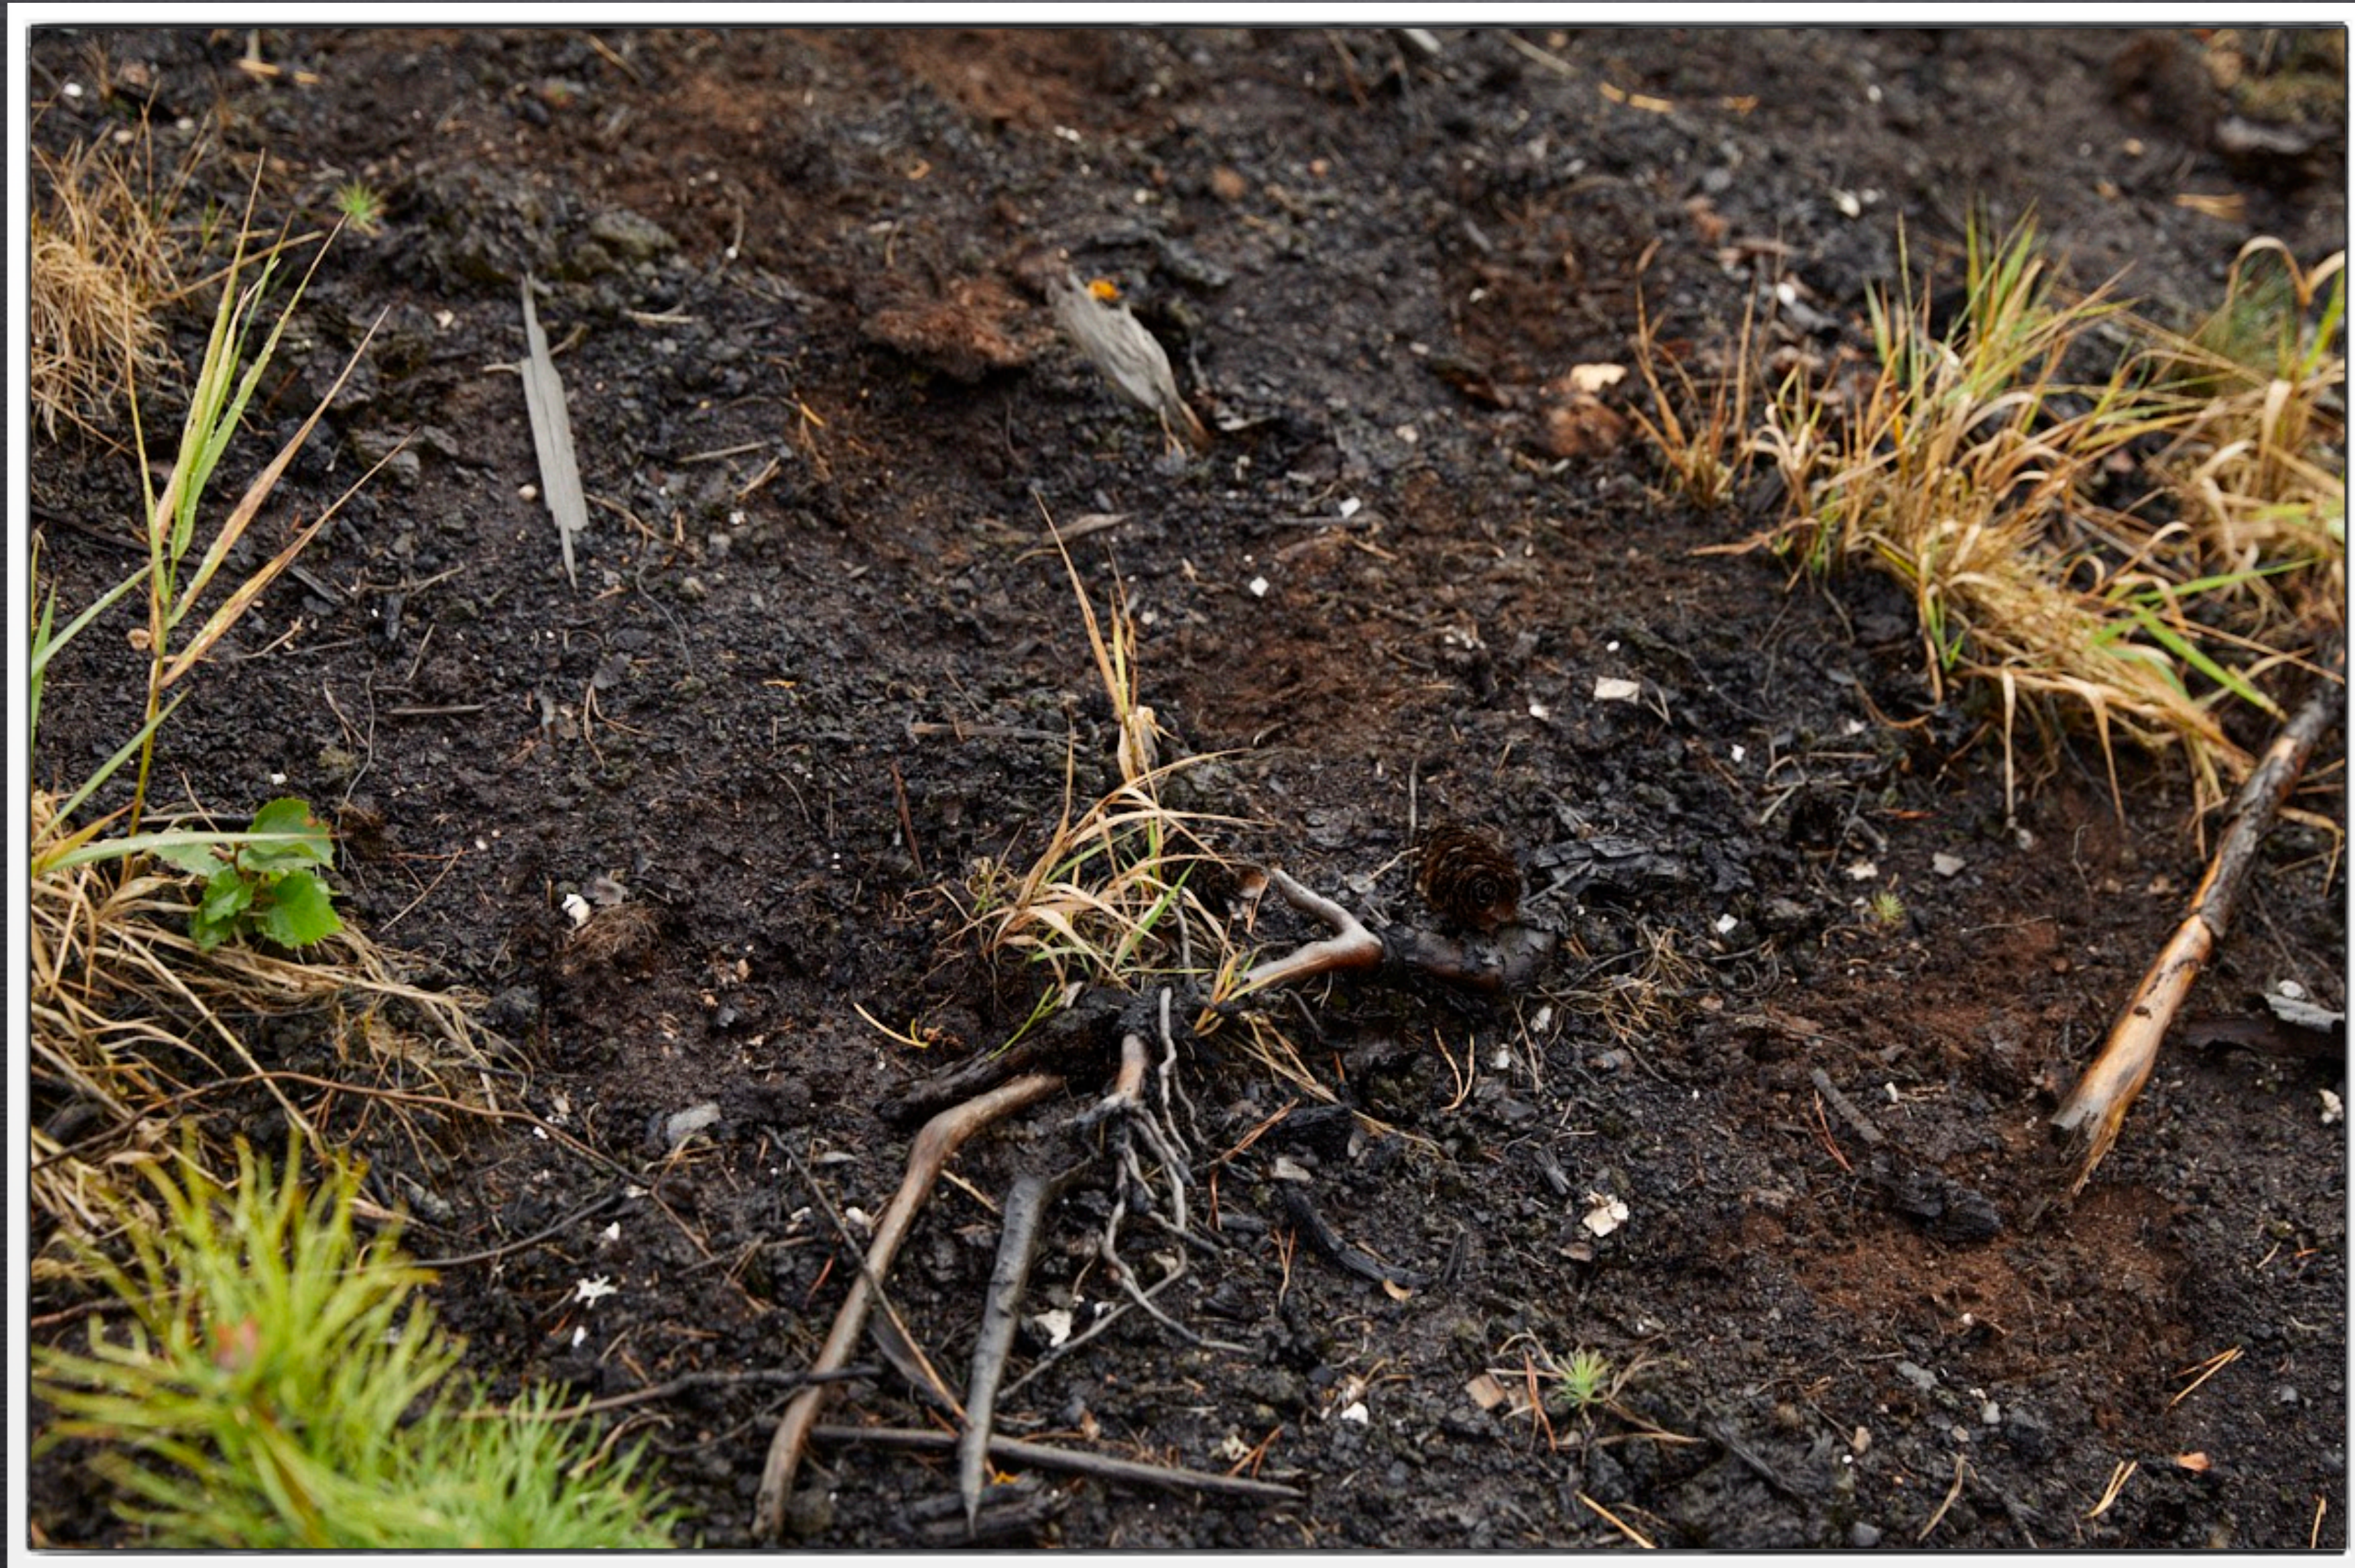
HÖVIDSTORPS WETLAND 2022-12-02

Since the wetland is constructed on a peatland with black peat, the colour of the water, iron, TOC and DOC increased over the wetland

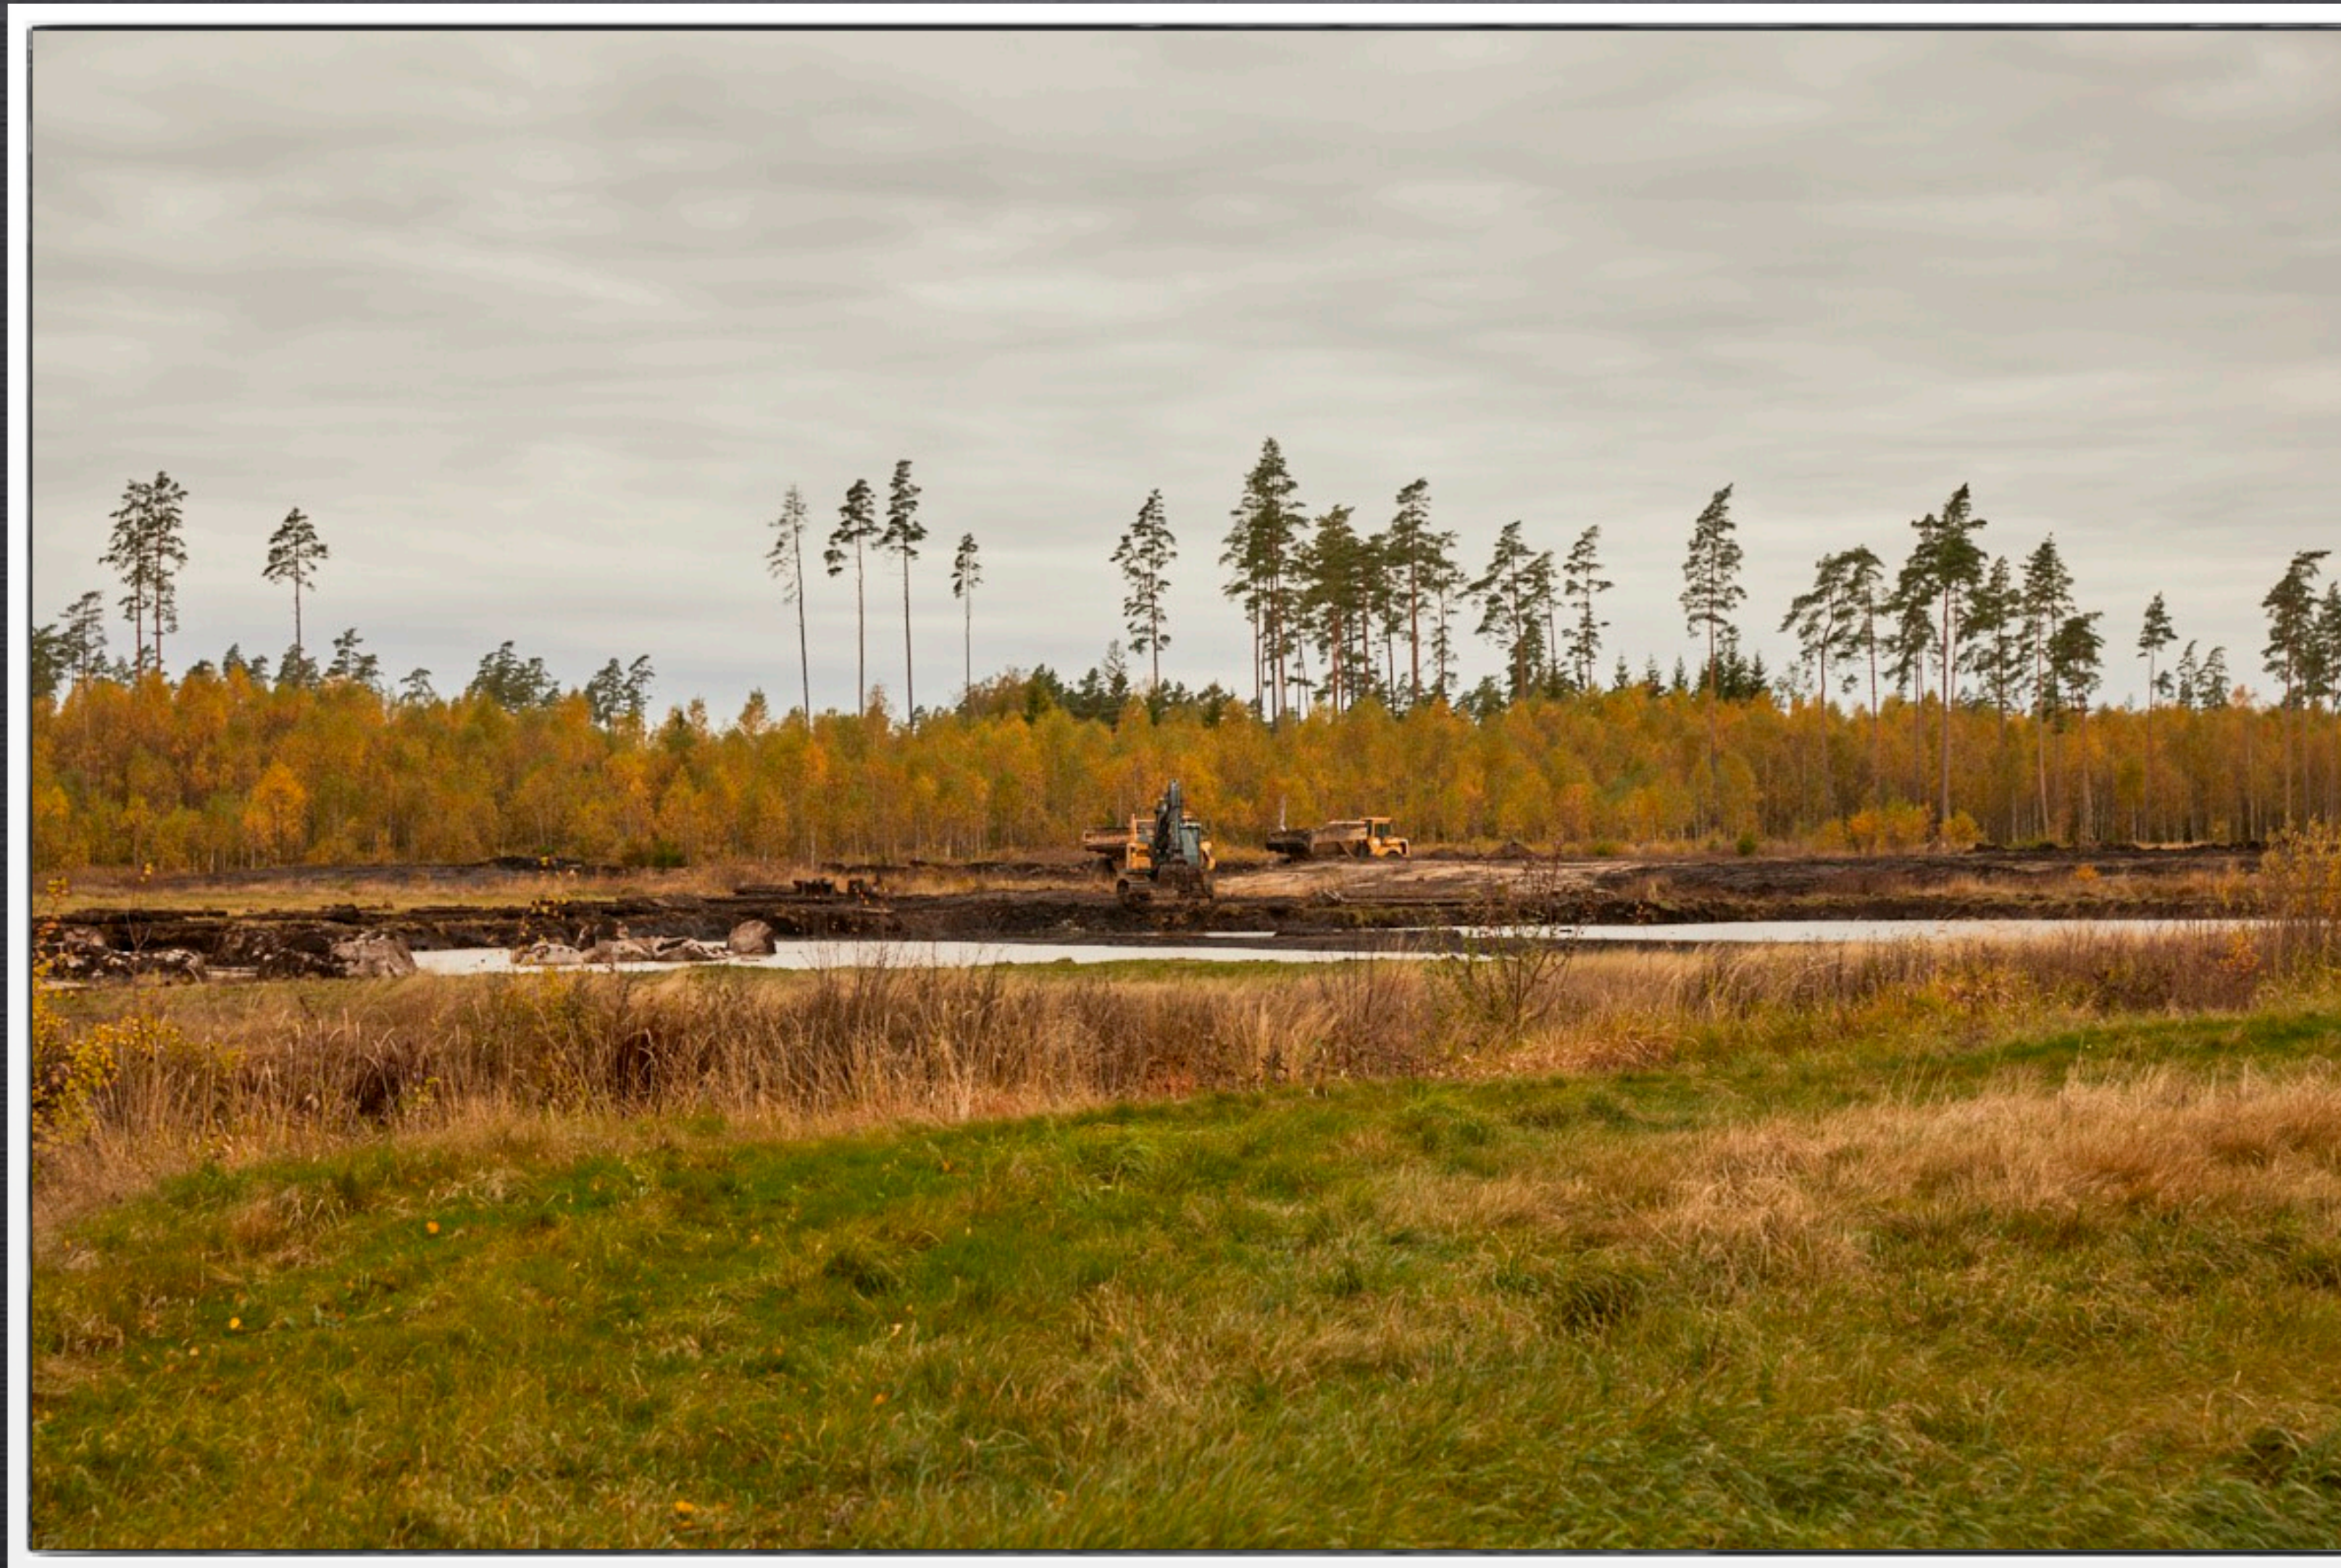
The water level of Lake Flyboda was lowered in the 19th century  
The river was straightened and converted to a channel with high, straight edges

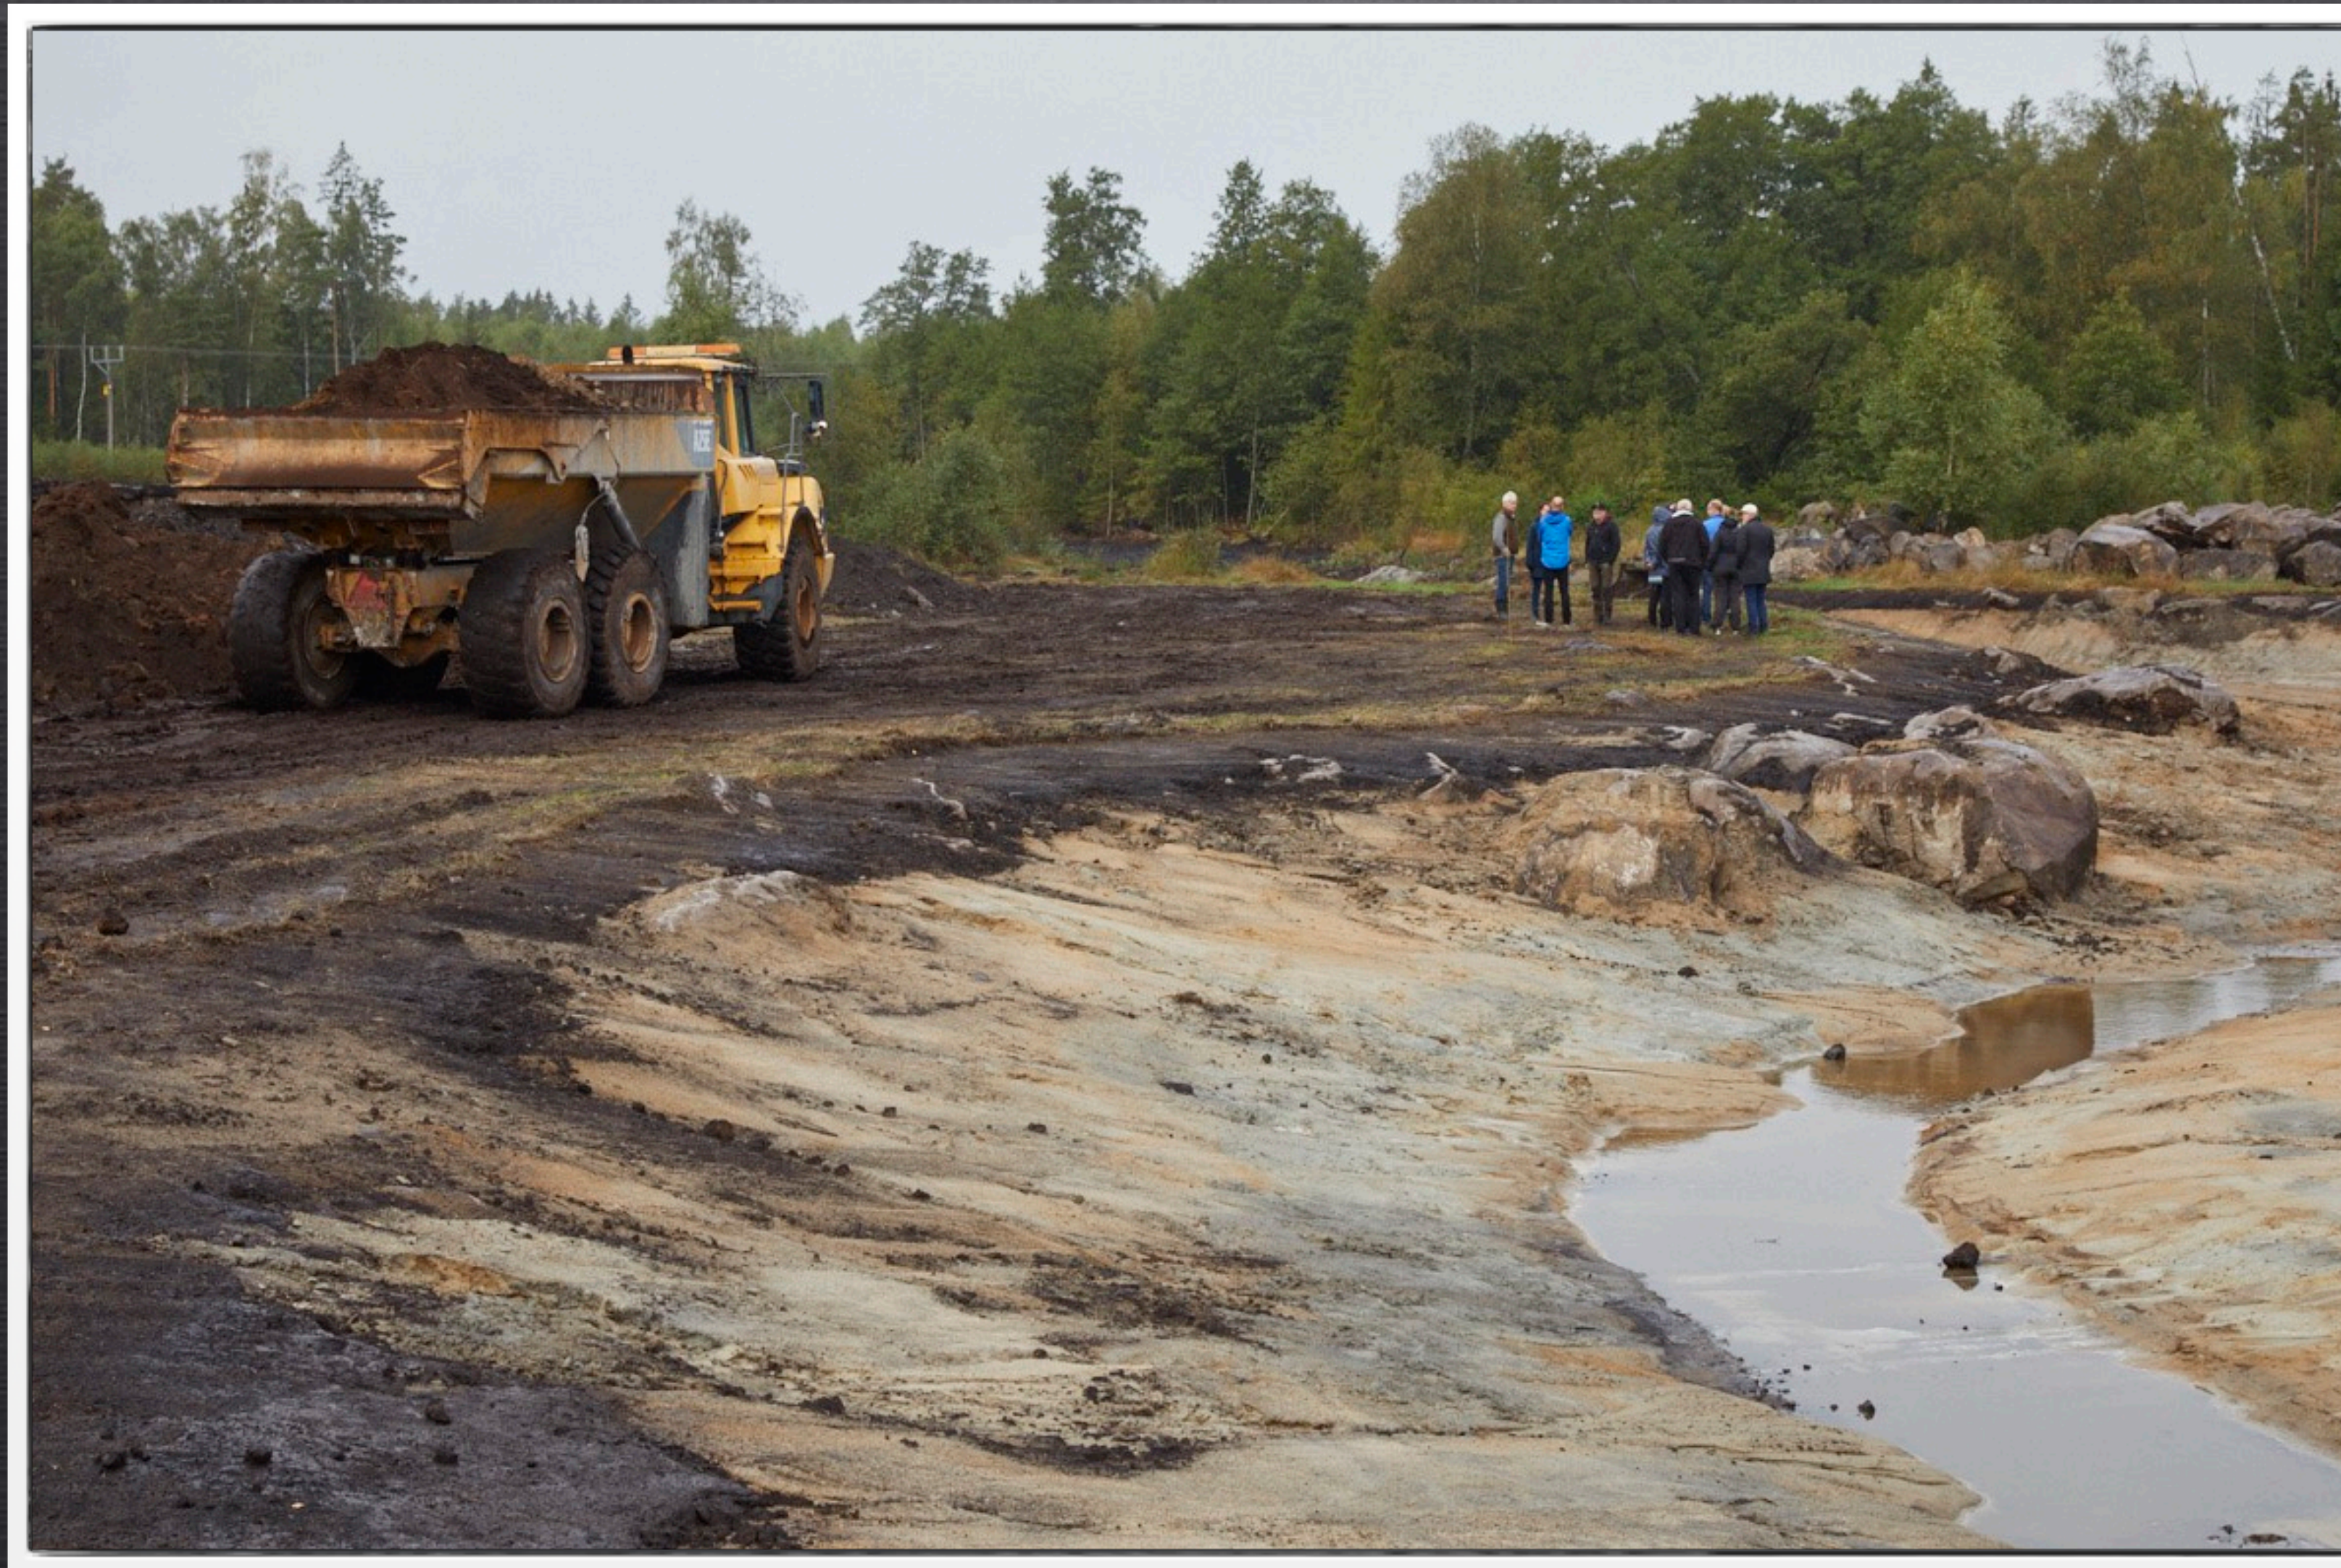
In 2022, a wetland with a meandering stream was constructed
