Agne Andersson  
Heléne Annadotter  
Johan Forssblad  
Emil Grönkvist

ÖSTRA  
GÖINGE

# A study of four constructed wetlands in the catchment of Lake Immeln Hövidstorp wetland

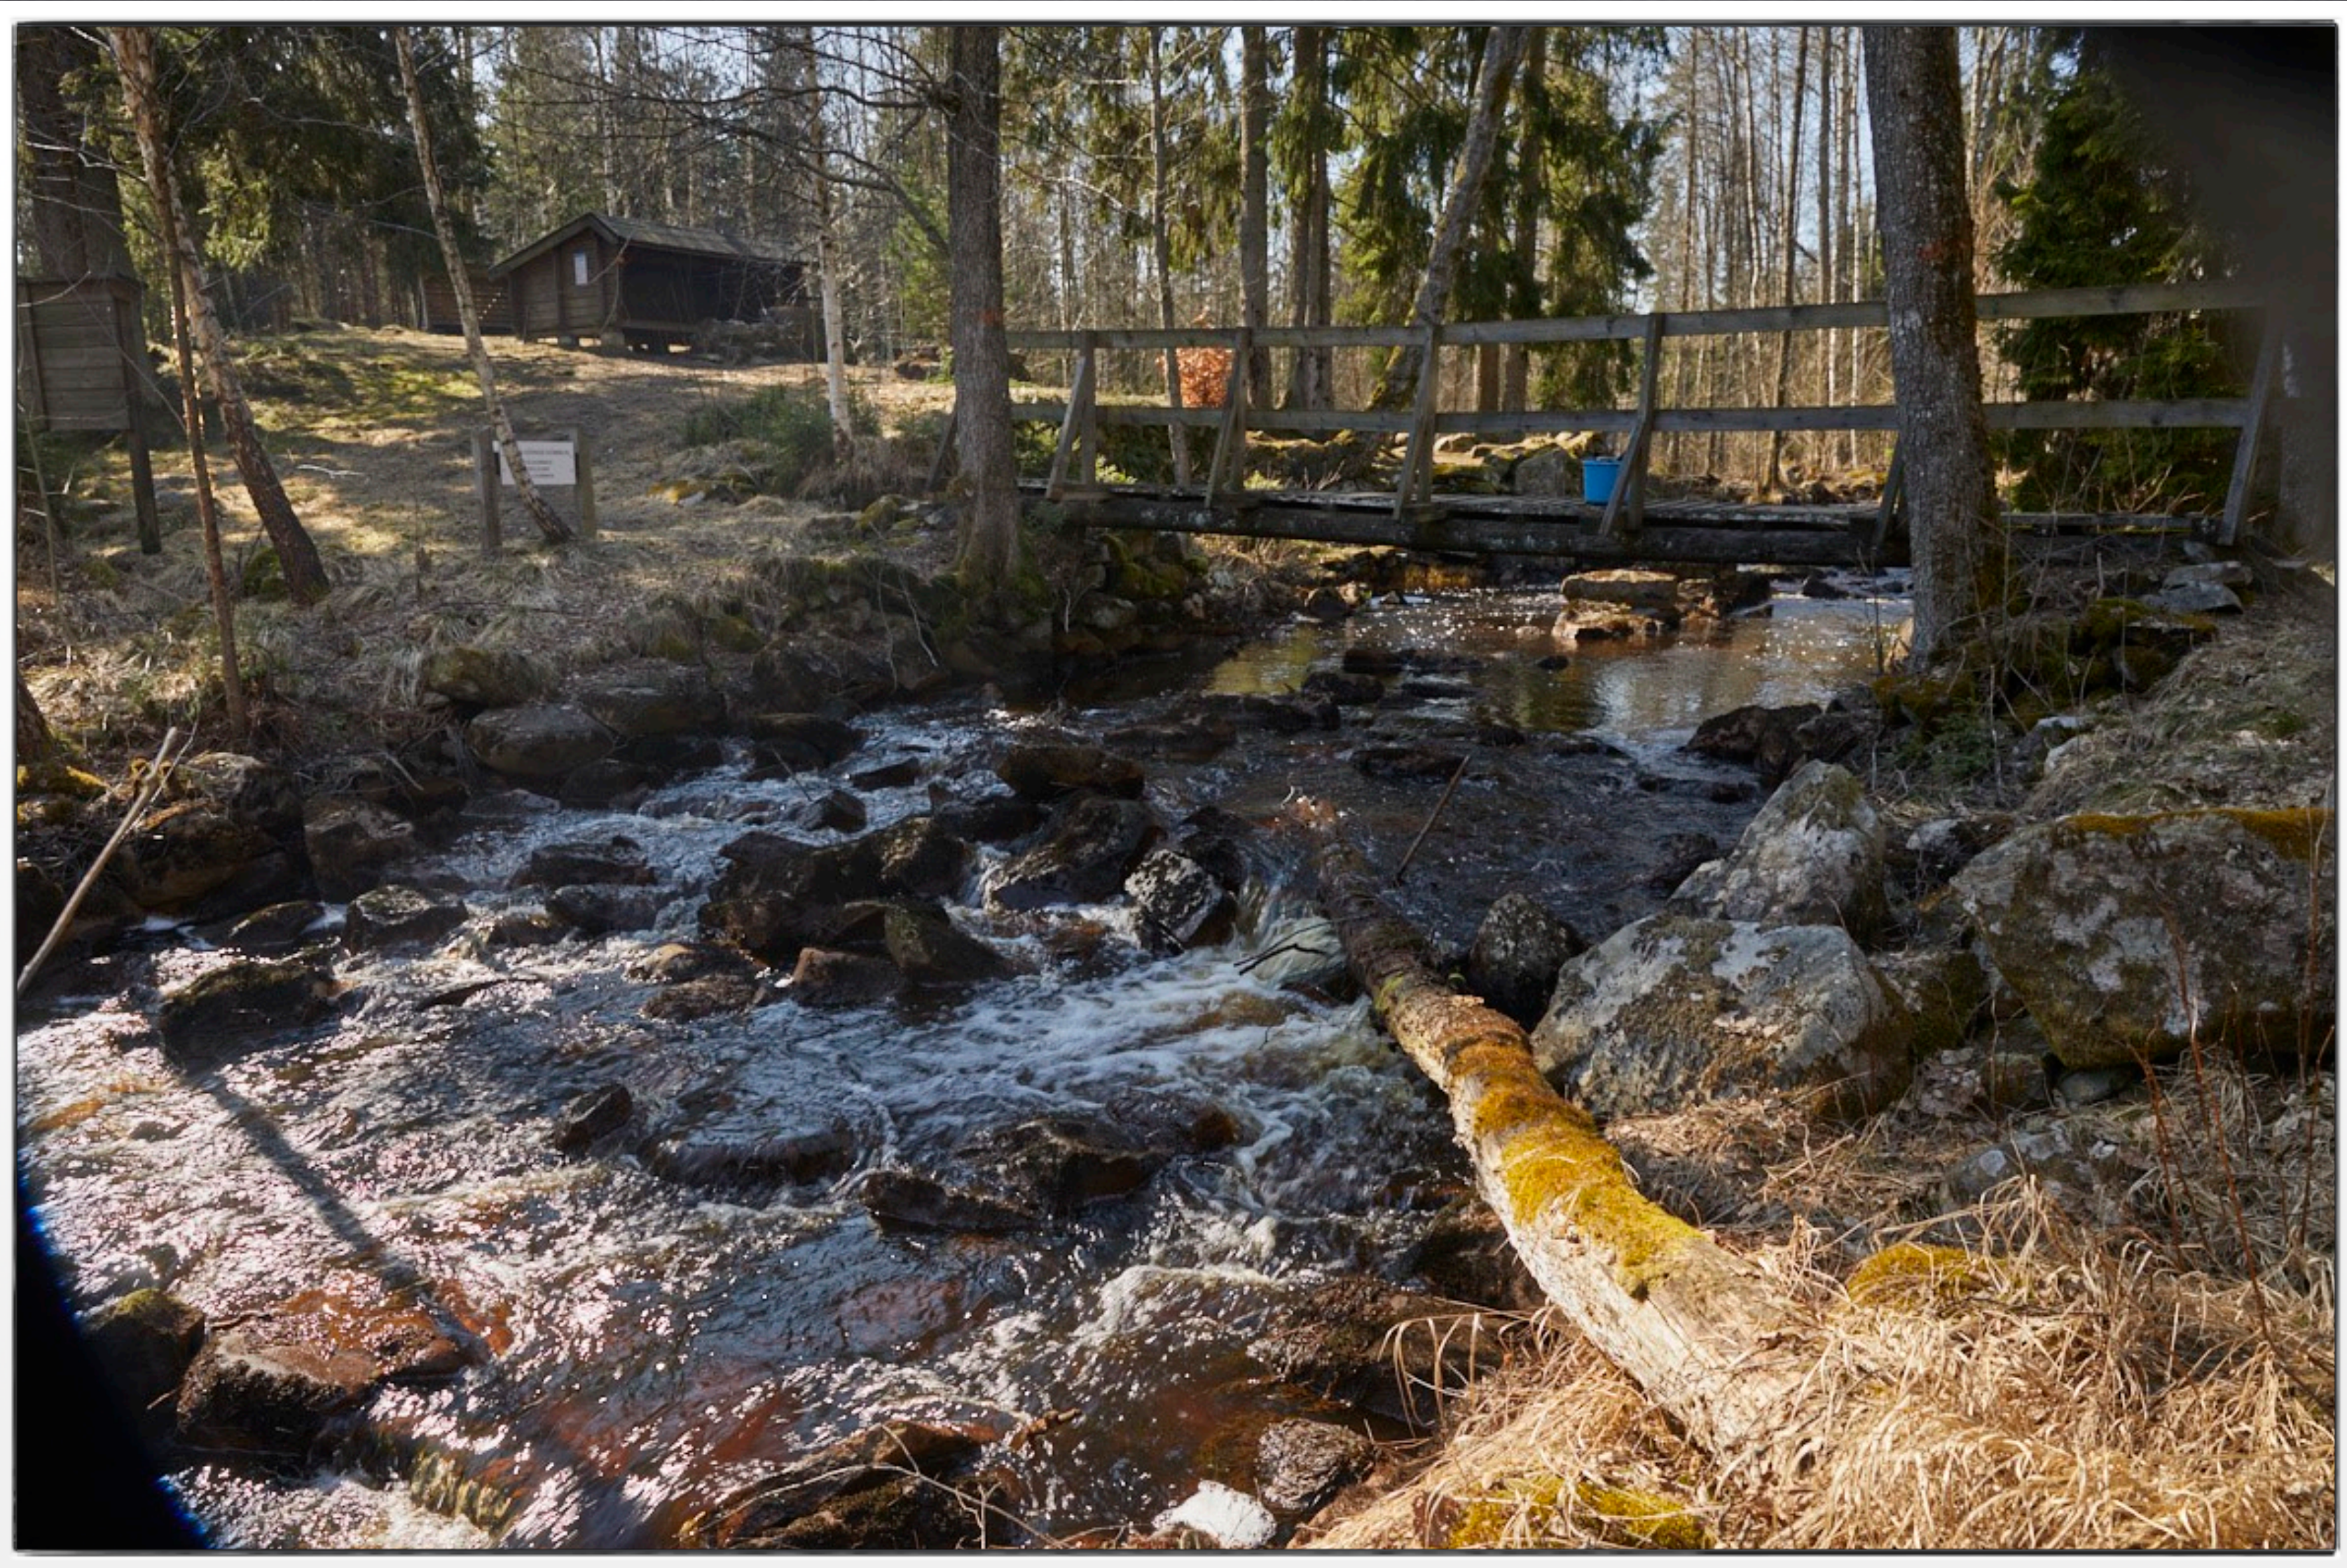
EKESHULTSÅN, BÖGLAREHULT

The demonstration site at Traneboda where different measures were created (2013-2014) in order to improve the water quality and the environment

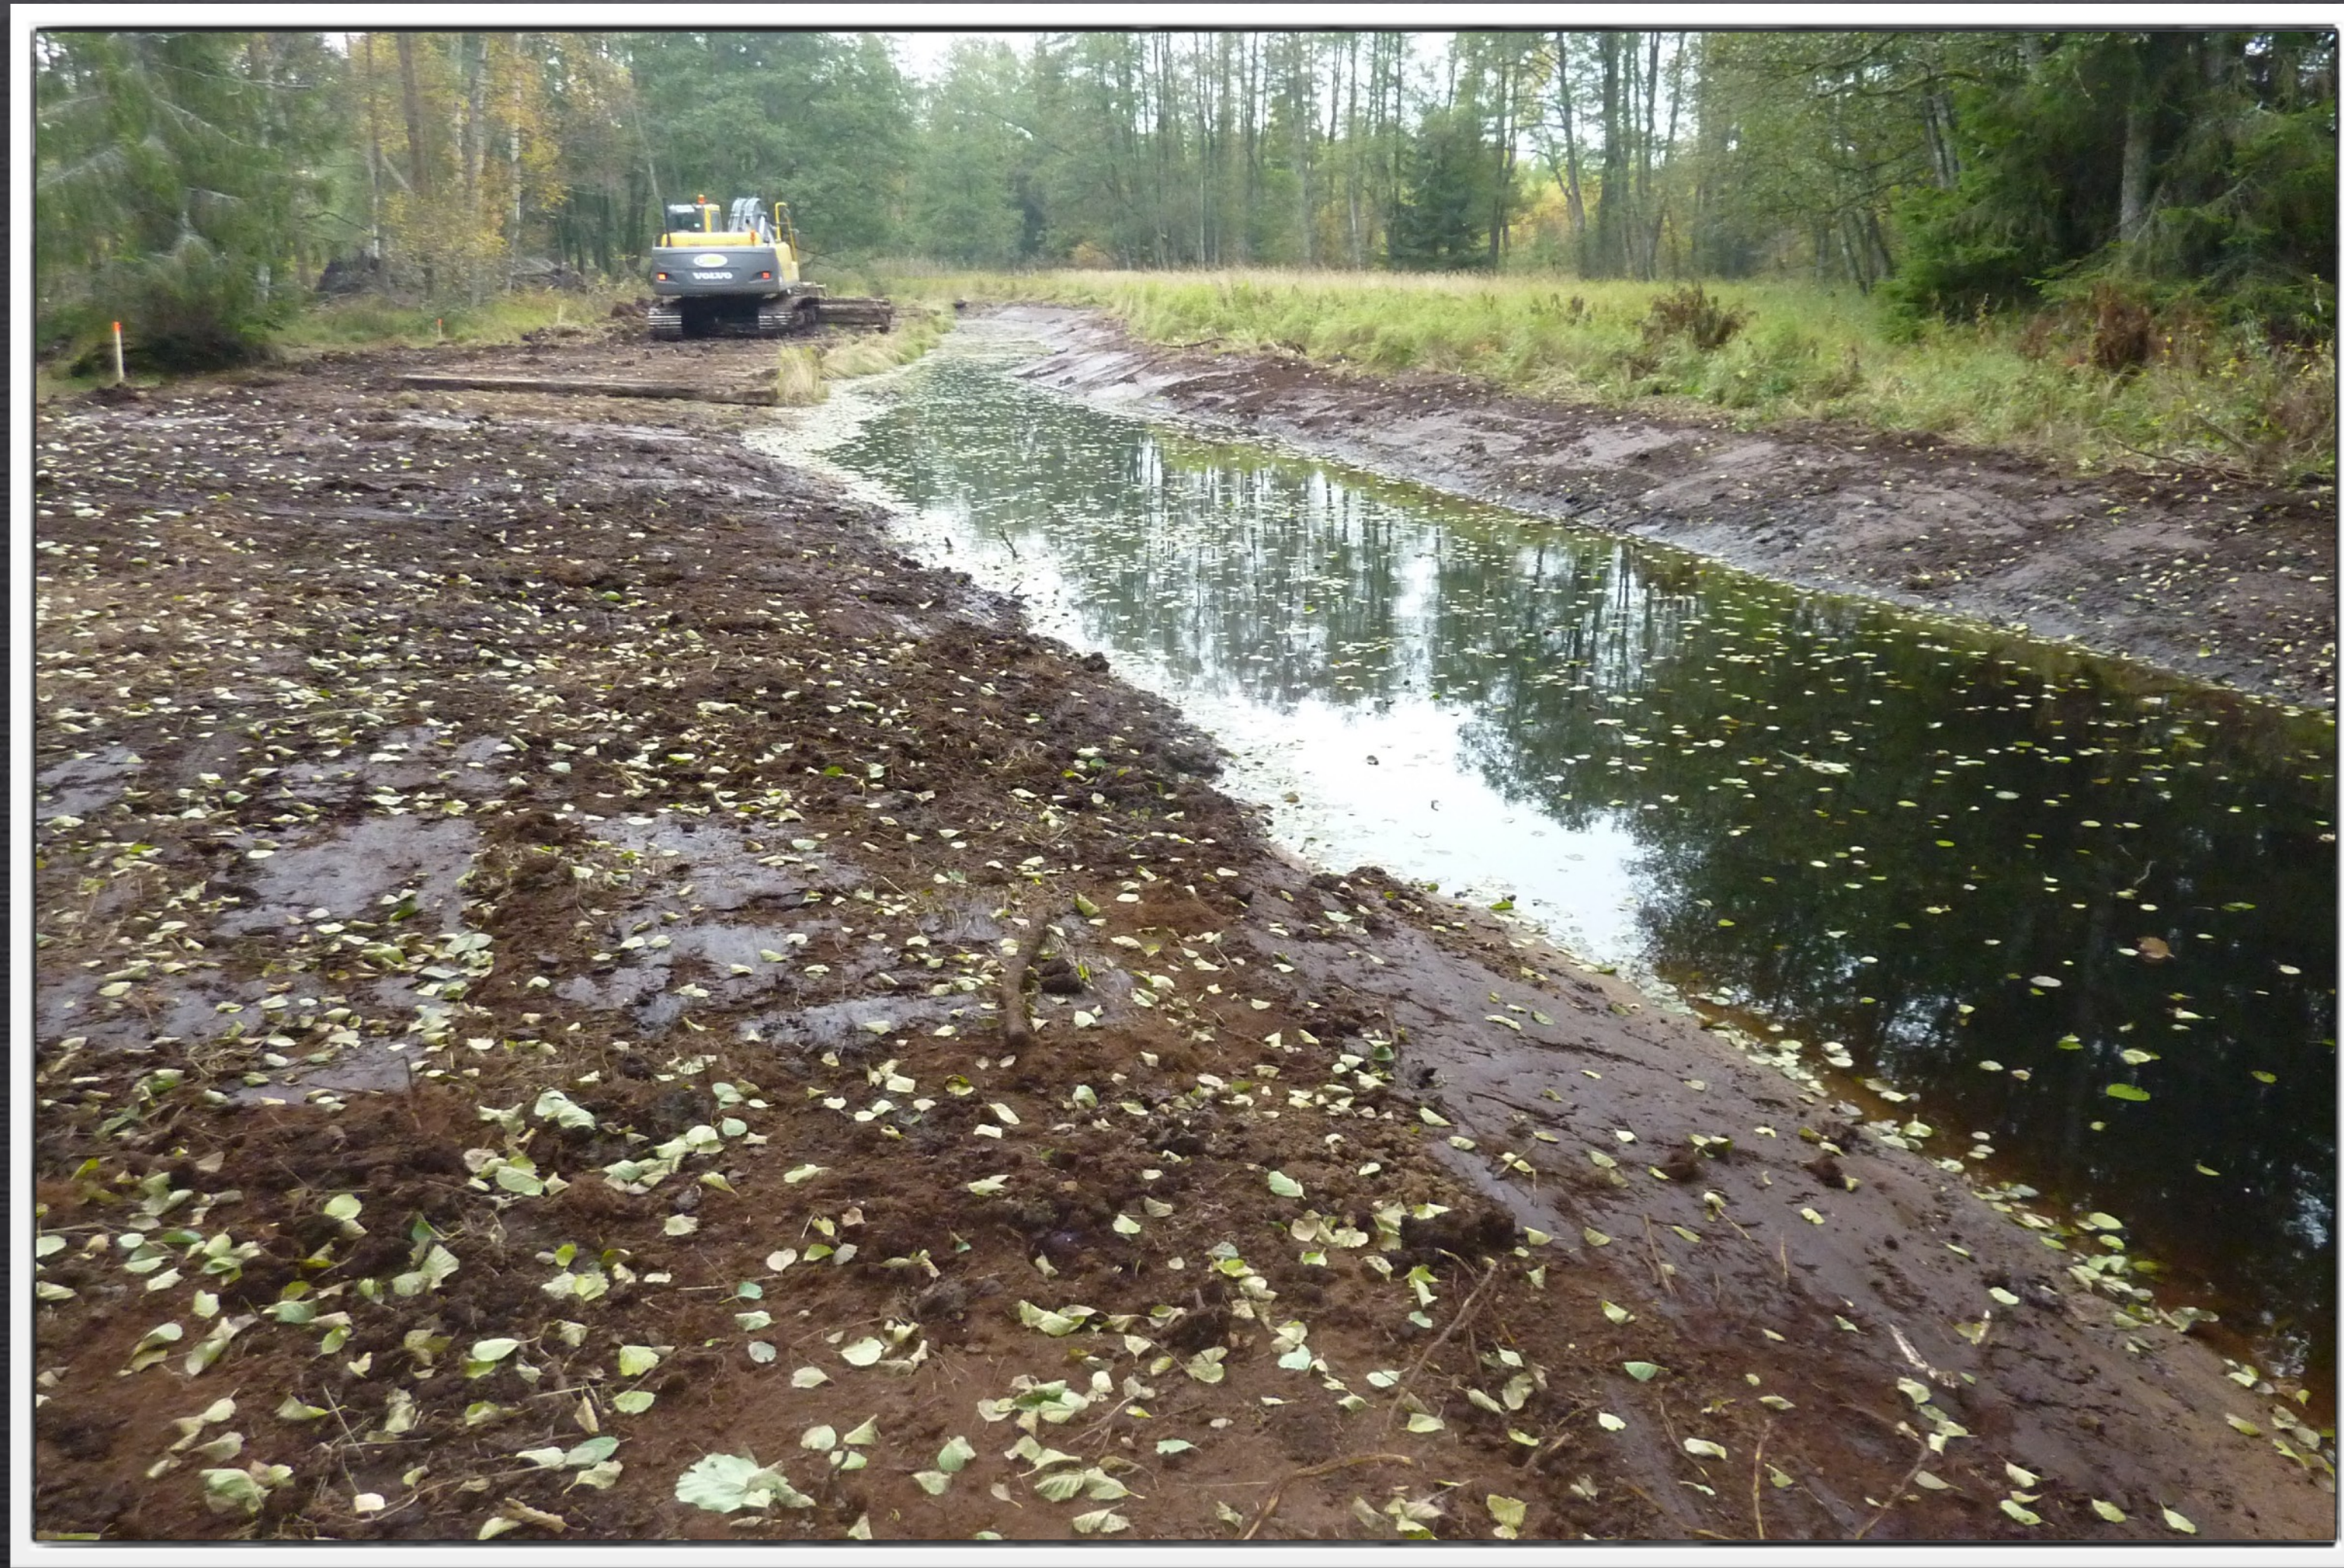
EKESHULTSÅN, TRANEBODA

In this area, previously high and sharp edges were levelled out to counteract erosion  
This also means that the stream can retain more water at high flows  
More habitats are created and it is easier for large animals to drink from the stream

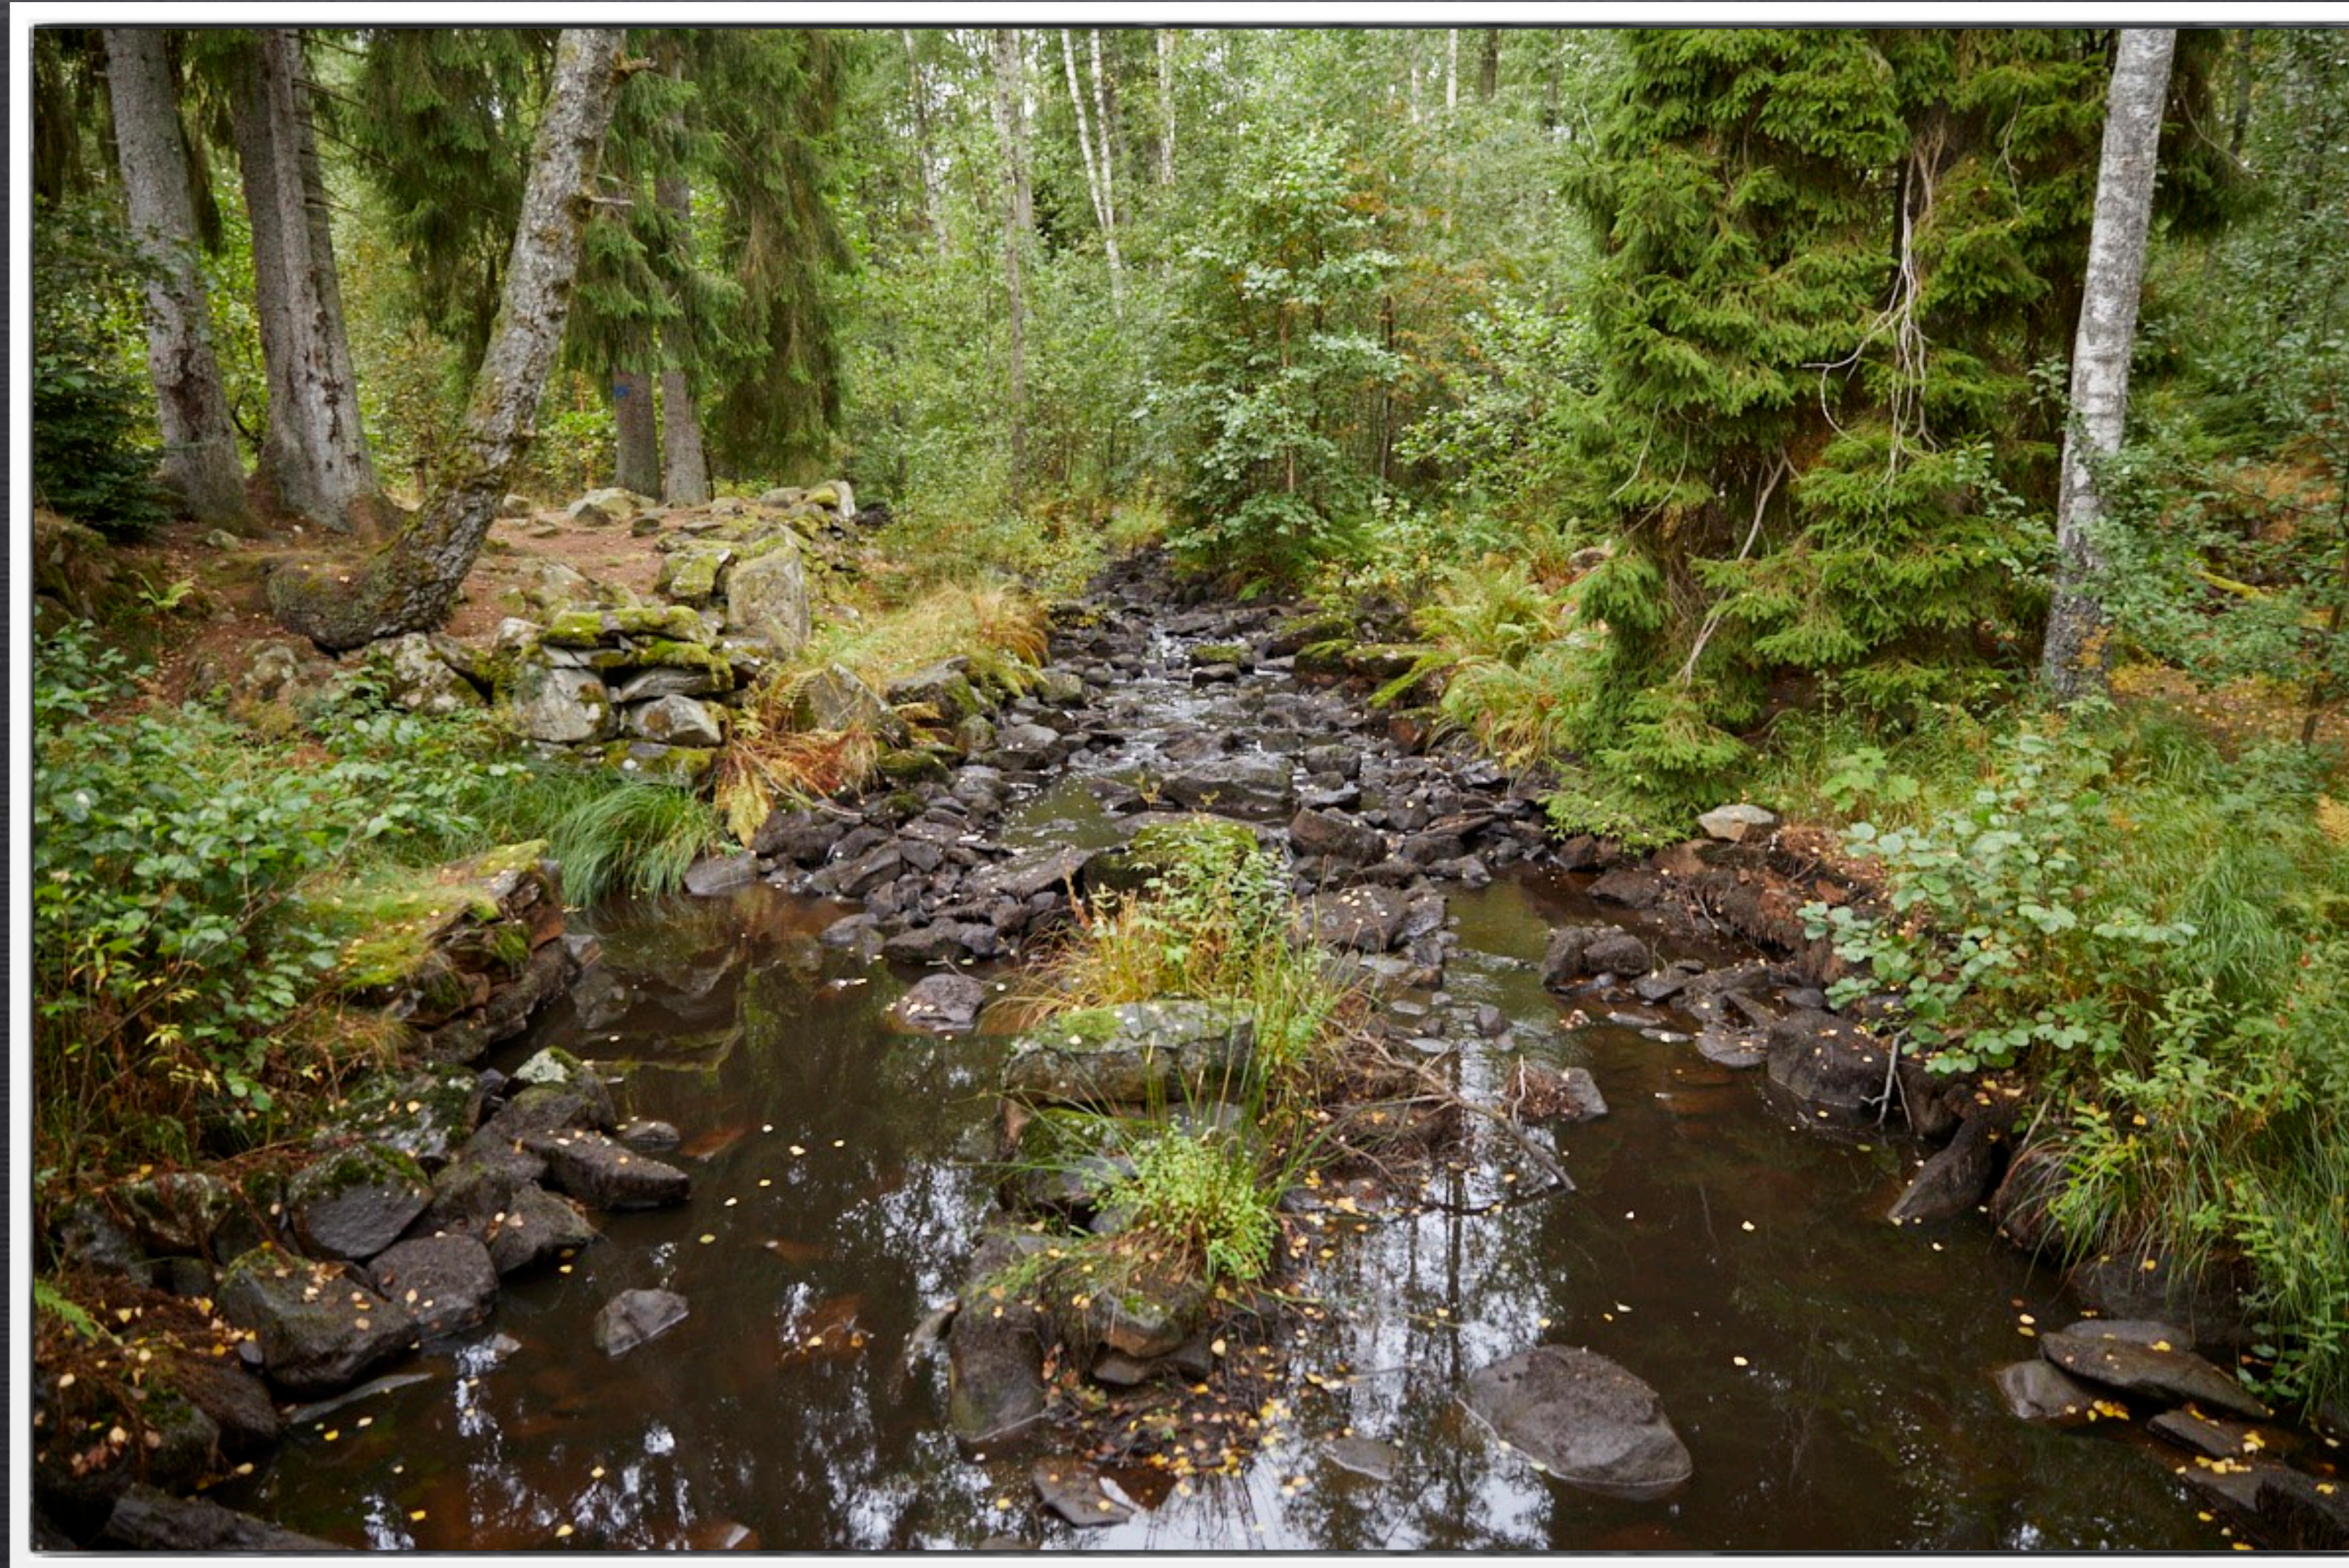
Placing stones in the river has recreated currents and calm water  
This has increased the number of habitats in the river which has lead  
to more species of bottom-dwelling insects

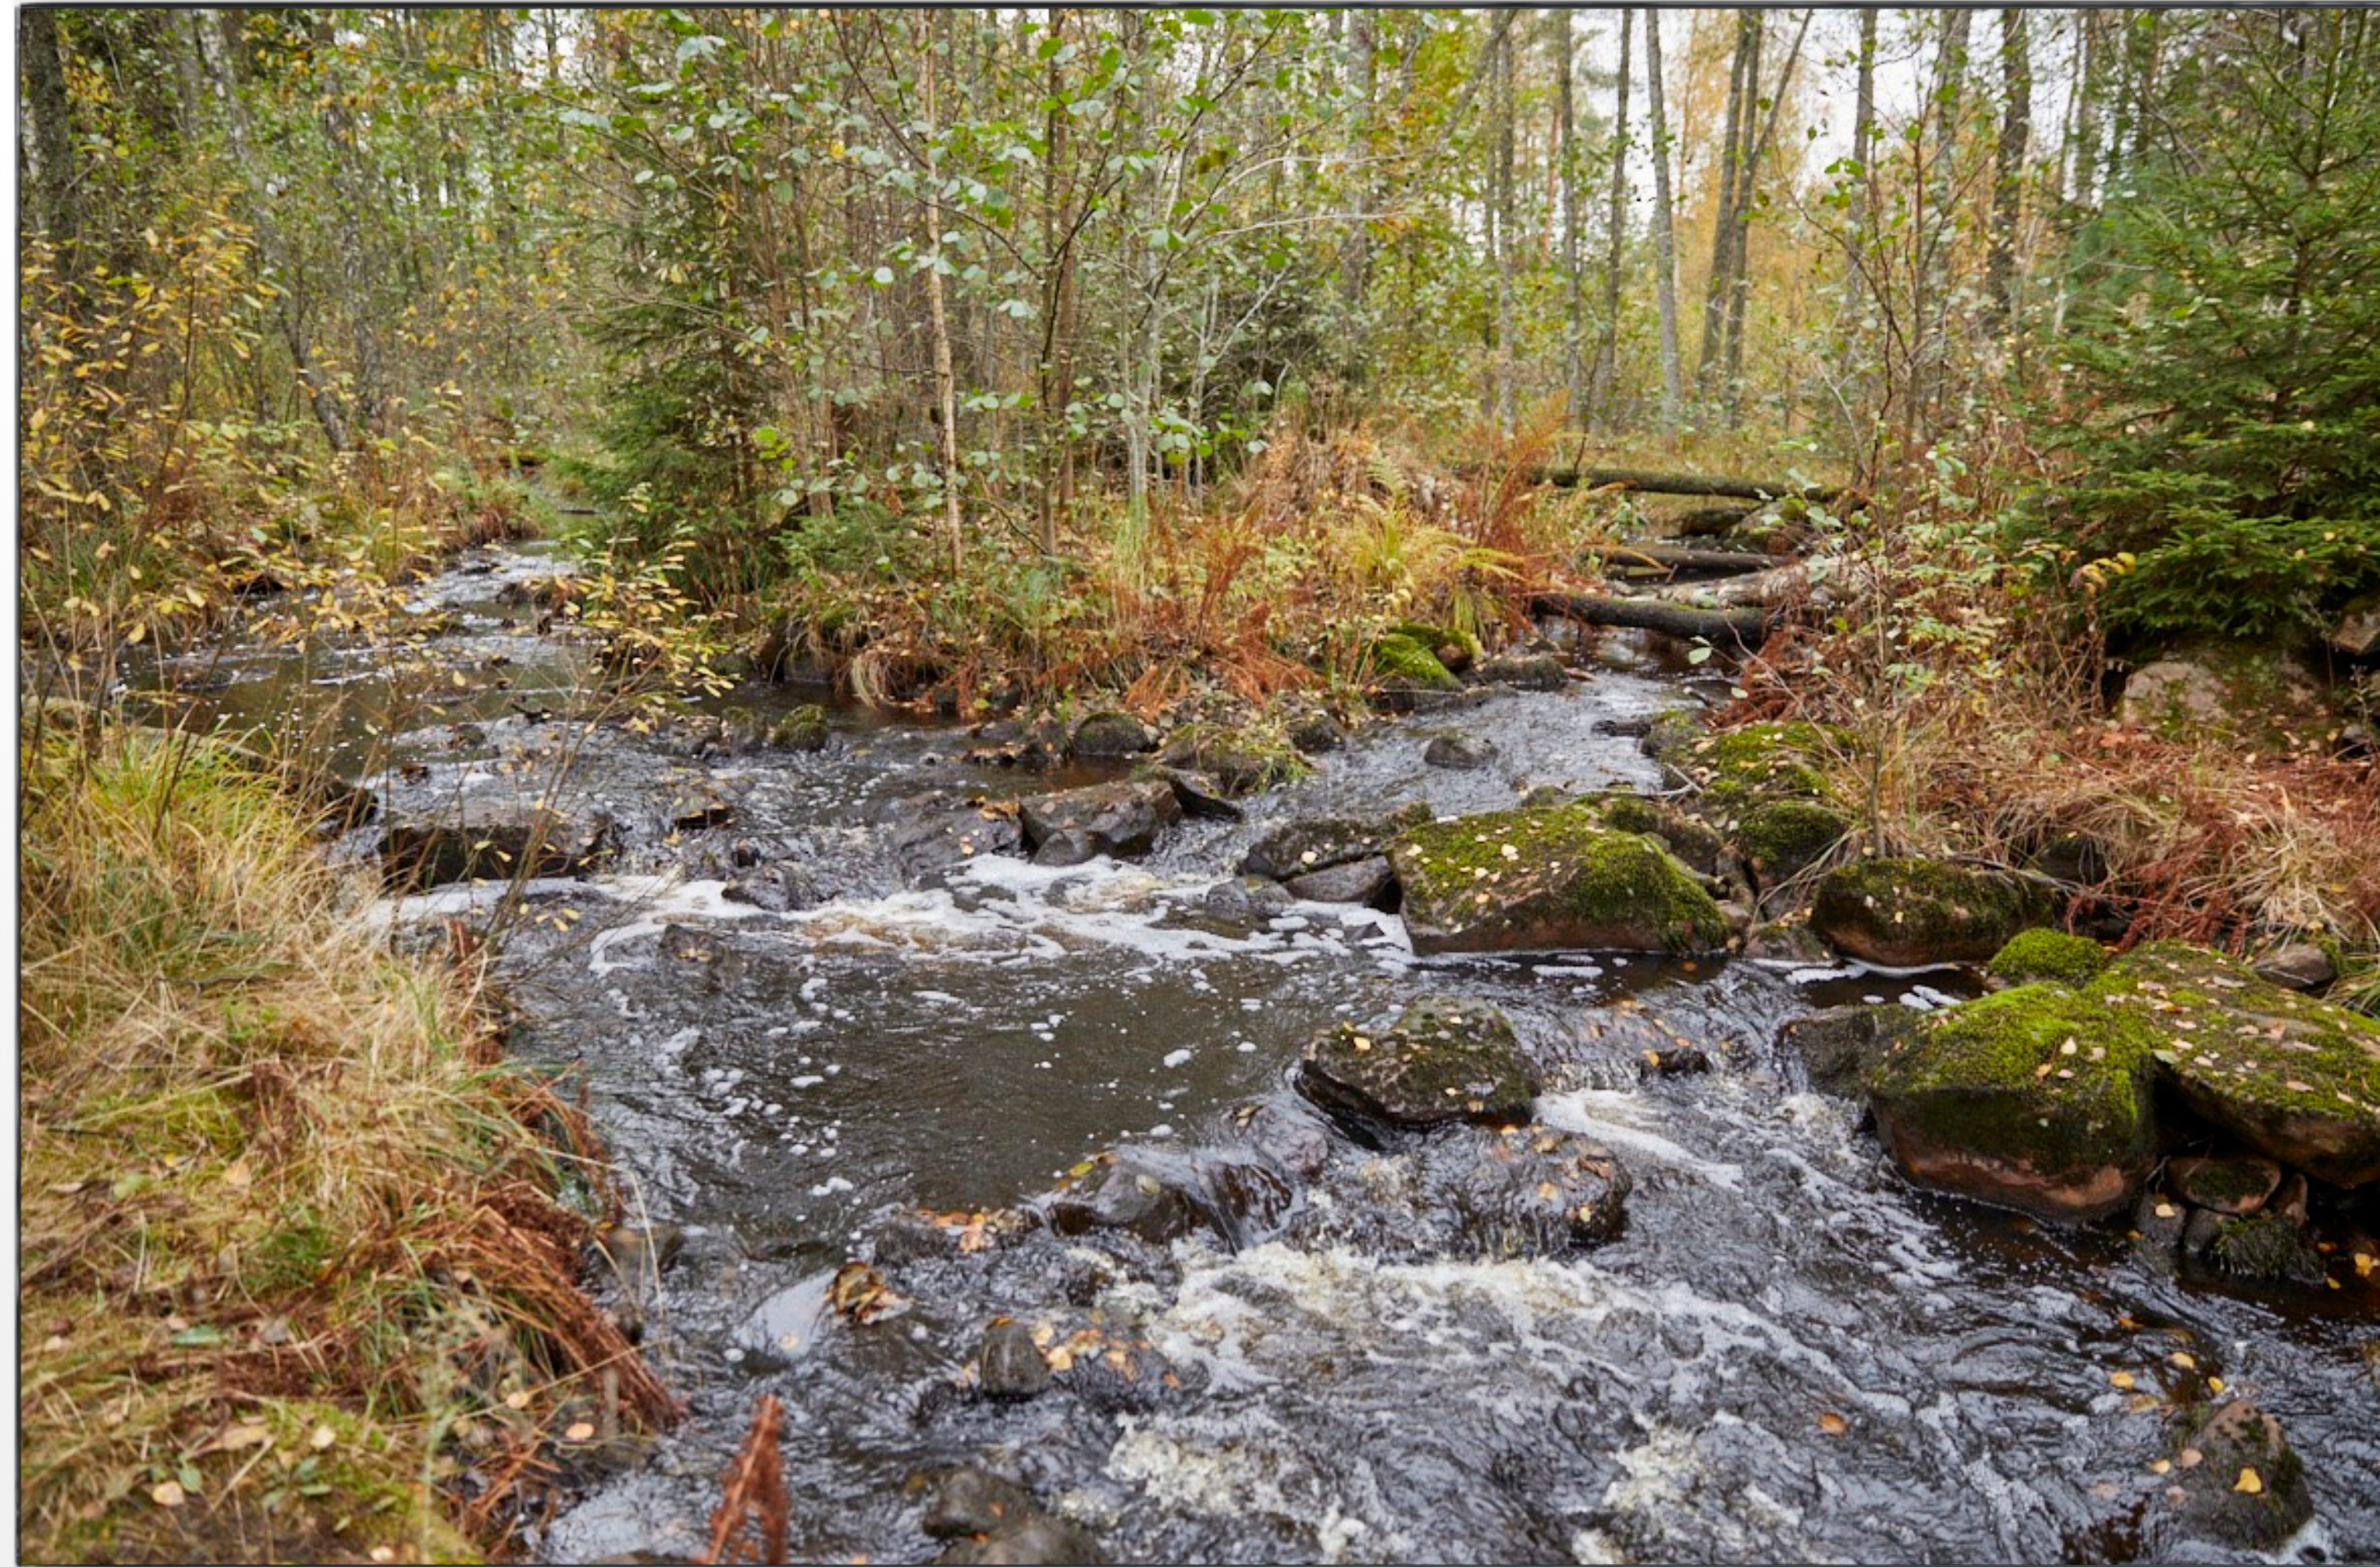
EKESHULTSÅN, TRANEBOGA

A quill area has been designed so that none of the furrows are left dry at low flows  
This is an optimal growing area for fish with flowing water, rocks, fallen trees and tree roots  
Here, the grey wagtail (*Motacilla cinerea*) thrives!

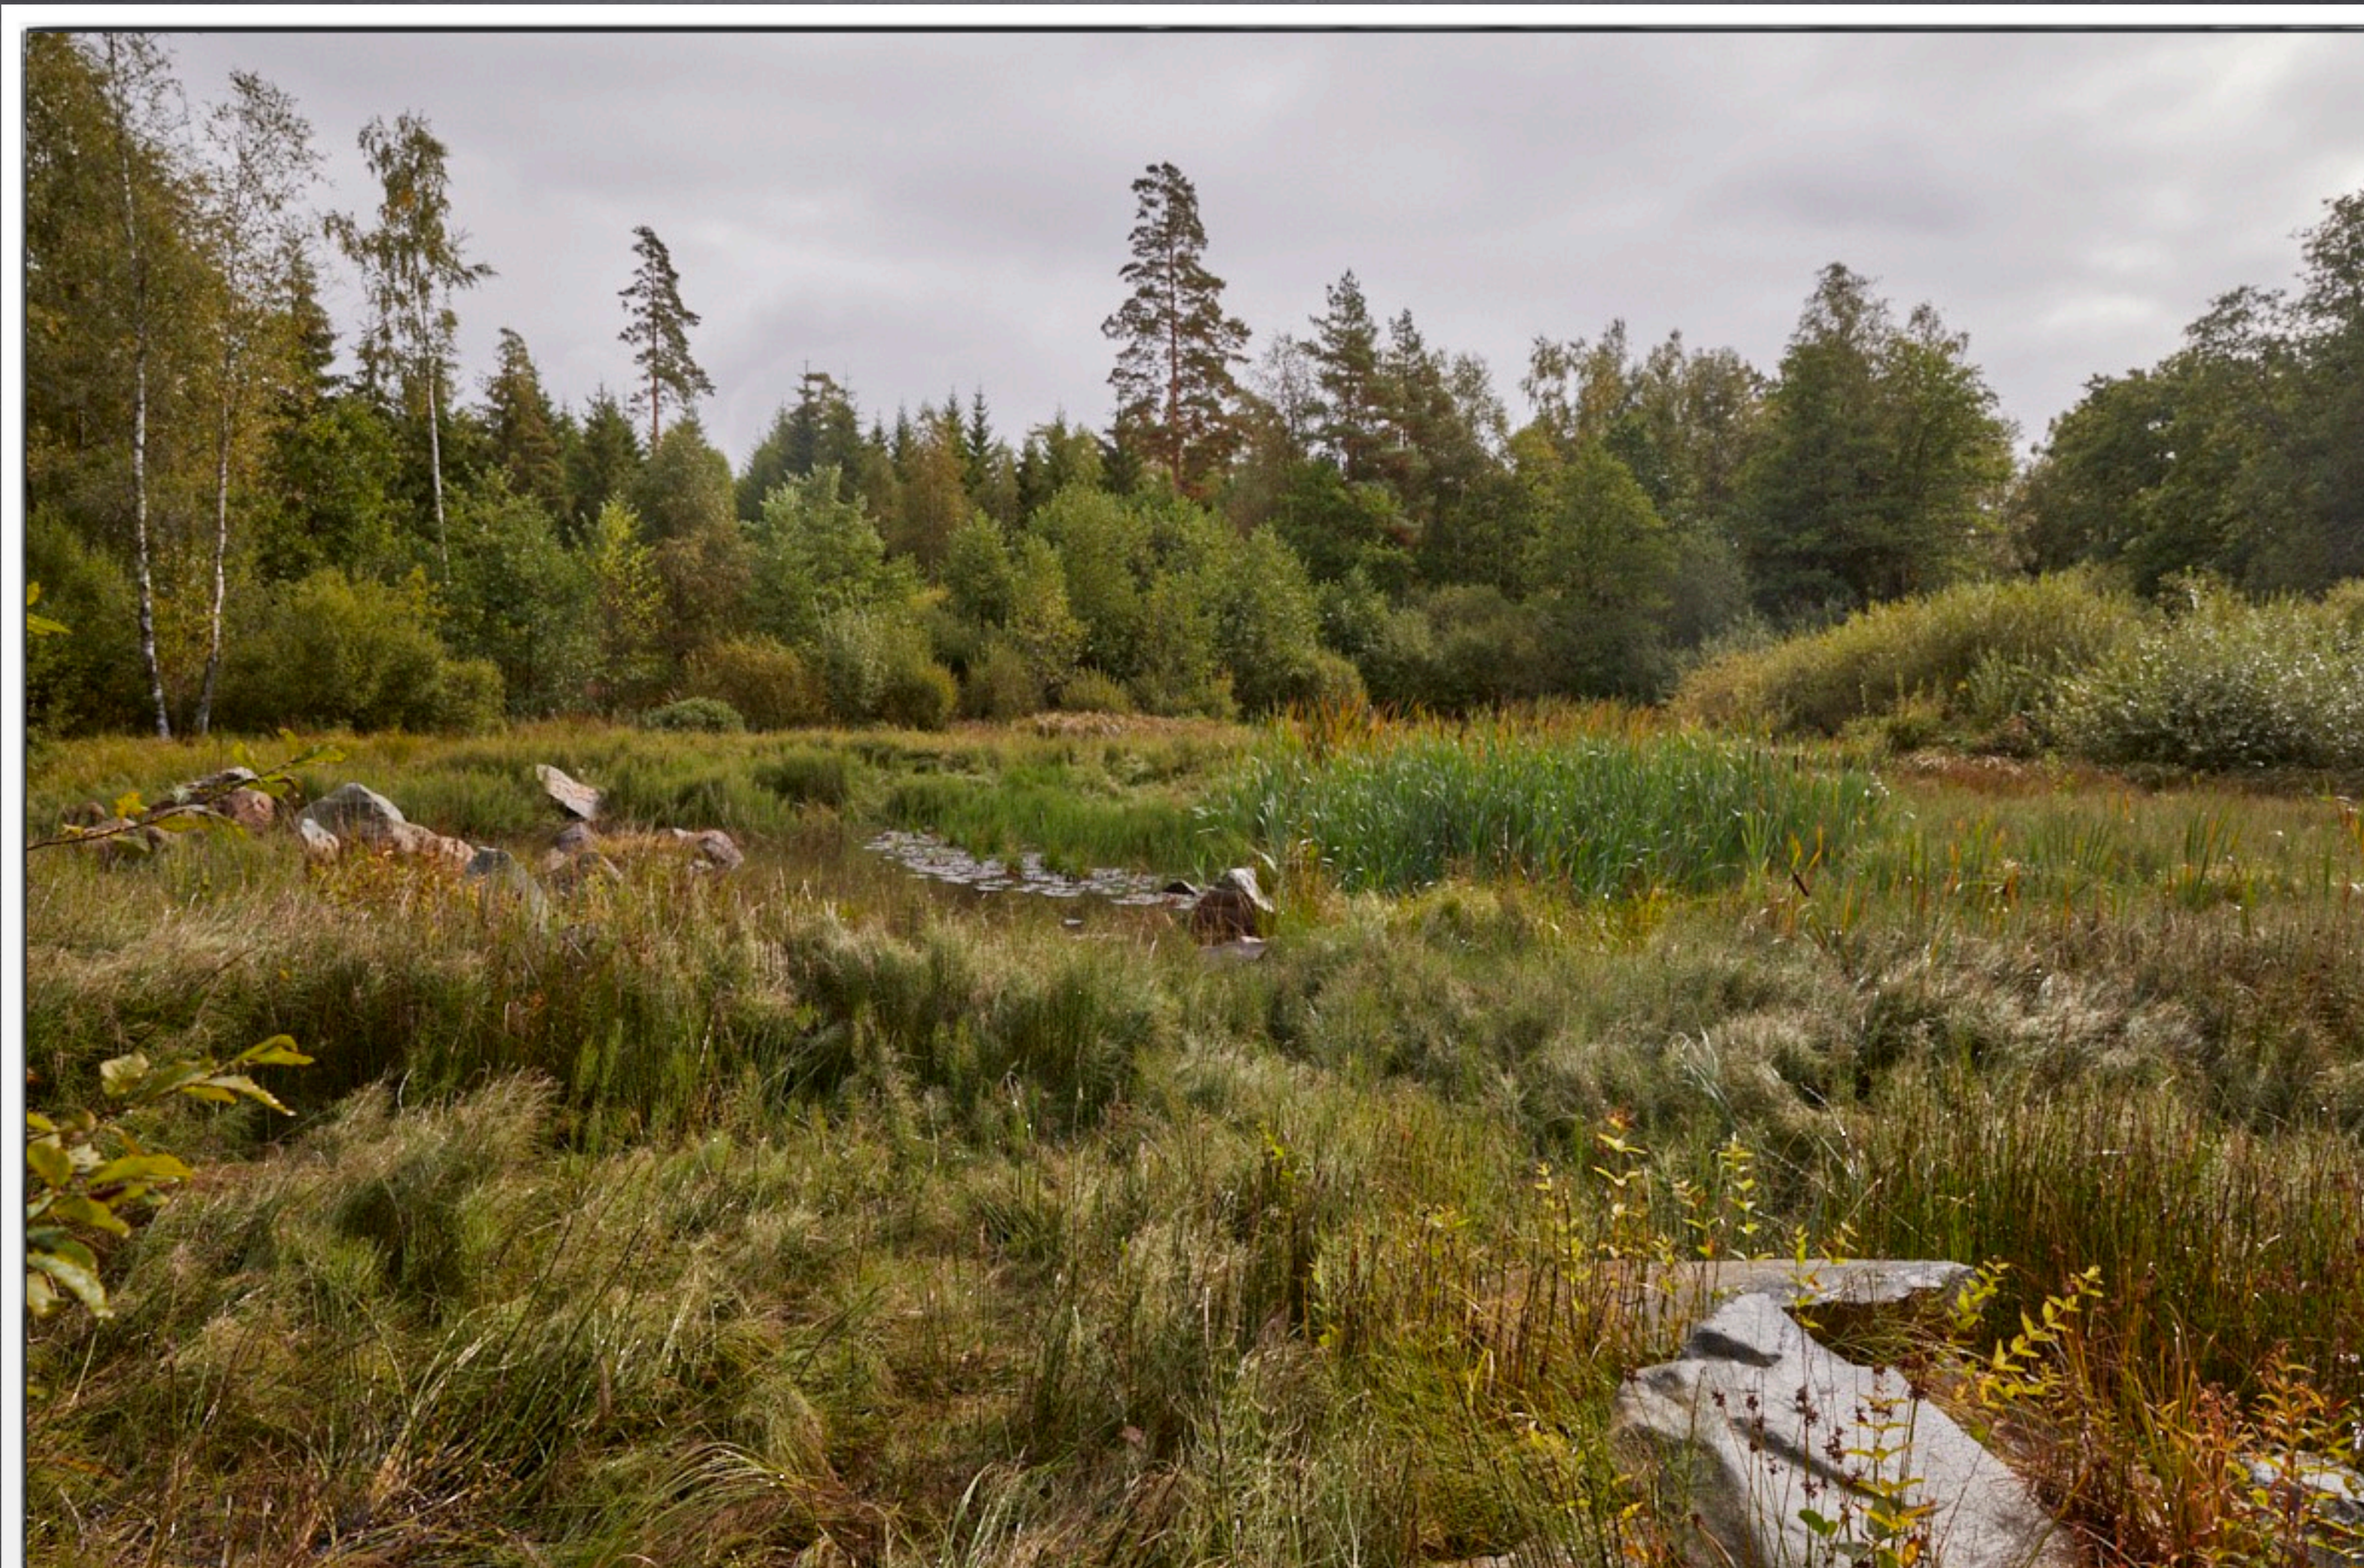
EKESHULTSÅN, TRANEBOGA

In June, at Traneboda, the colour of the water decreased  
from 556 to 425 mg Pt/l over the demonstration site  
This could be due to constructed wetlands connected to the river

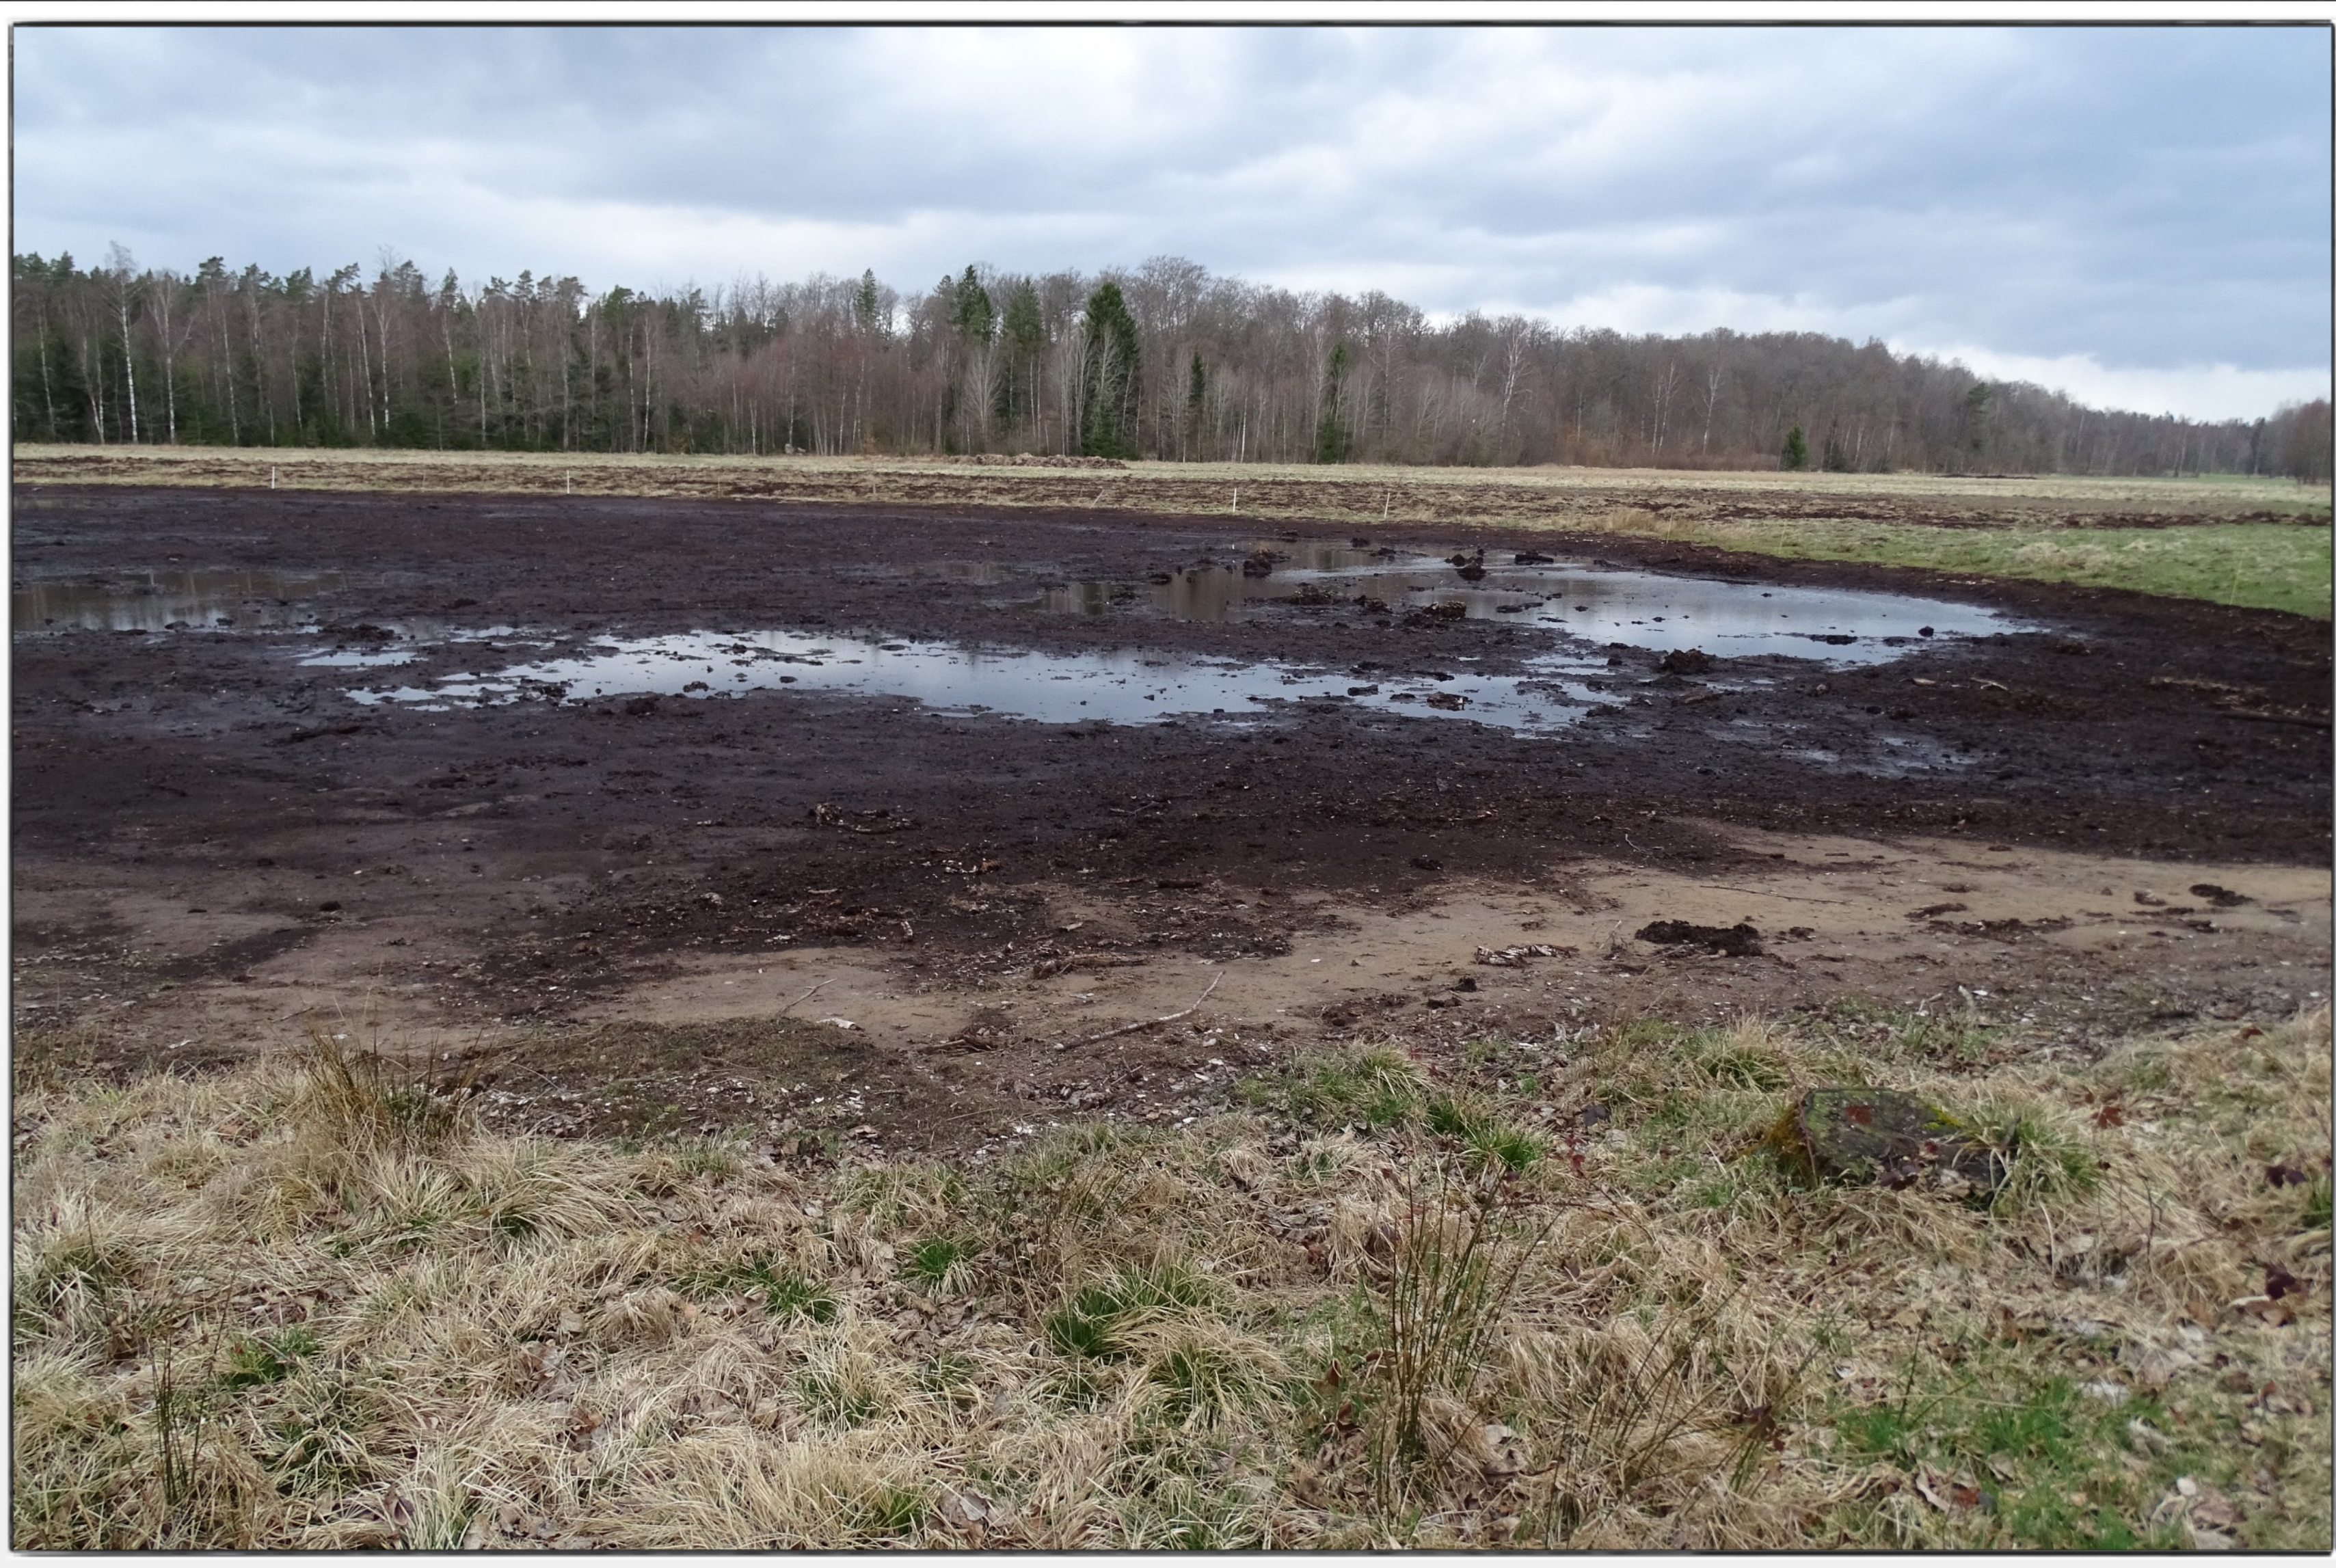
GRIMSBODA 2022-03-23

In Grimsboda, a wetland was constructed in 2015
